Structural Rehabilitation of the Kenilworth PCCP Transmission Main with Steel Slipliner

ABSTRACT

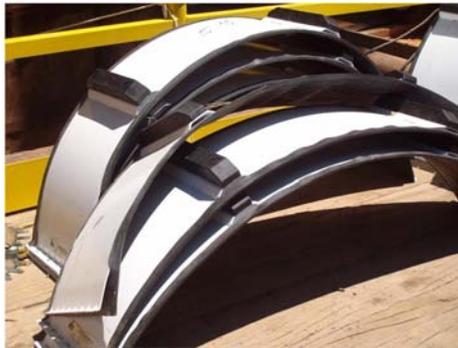
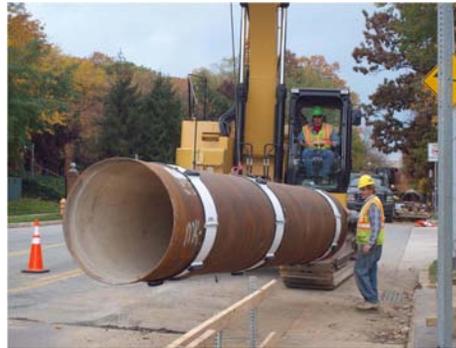
Figures 4a, b: Casing Spacers, 3 Casing Spacers per 20-ft Steel Cylinders

The Contractor used casing spacers to center the steel pipe in the host PCCP. The casing spacers were made of hard polymer plastic, Figure 4a. Three casing spacers were used for each 20-ft section, Figure 4b, and two spacers on 10-ft sections. This system allowed the WSP to easily transverse through the host pipe, and also articulating at offsets, angles and bends. These spacers provided a uniform space around the liner pipe in preparation for the grouting process.

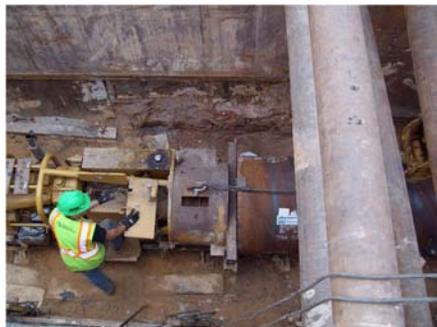
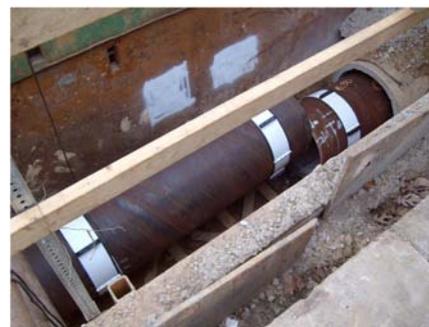
Figures 5a, b: Jacking Machine, Cartridge-Method Insertion

The contractor constructed ten pits, including tie-in locations. Each area was sufficiently long to accommodate the pipe lengths and the jacking equipment. Sliplining lengths varied from 600-ft to 1000-ft. Pit locations were selected based on bends from the drawing details, pushing distance and connection areas. The contractor excavated the area and pulled out the original section of host pipe in this immediate area, but left the areas adjacent to the openings with the bottom of the PCCP in place. This base gave the steel pipe a track to place the slipline pipe, prior to pushing in place. All areas of the open pits were dewatered during this operation. Instead of using a rail system as would typically be the case, the contractor used a jacking machine with a connection sled to push the pipe into place, Figure 5a. Pipe was located with the corresponding mark number and loaded onto the sled, sequentially in cartridge fashion. Mark numbers ensured that the correct pipe section was being inserted so that it would find its correct location in the slipline operation. The contractor's jacking equipment was limited to performing 800-ft long jacking operations. For several of the 1000-ft sections, an excavator was utilized to facilitate movement of the steel liner pipe downstream while the jacking machine continued to push on the upstream liner sections, enabling the completion of the 1000-ft runs of sliplining.

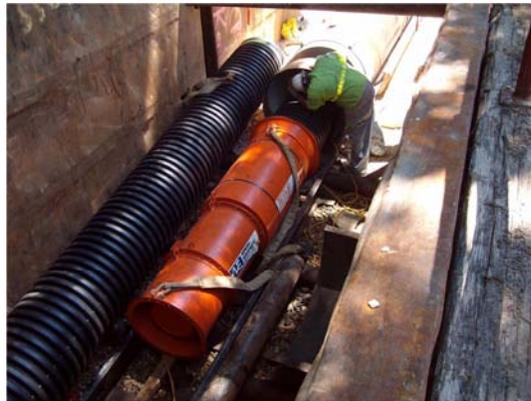
Figure 6: OSHA Approved Ventilation Equipment w/ Corrugated HDPE Ducts

Welding: After each pit-to-pit train was completed, welders went into the pipe to internally lap weld each piece of pipe. Pipe welding was completed per AWWA C206 (AWWA 2003) and AWS B2.1 (AWS 2005) — standards for field welding procedures and welding qualifications, respectively. The contractor utilized OSHA approved confined space entry equipment and apparatus, Figure 6. After welding completion, the specifications required that each weld was third party tested with a magnetic particle examination per the ASTM E709 (ASTM 2001) standard. After each weld was tested and approved, the Contractor used a cement epoxy compound to grout the internal joint to provide a continuous cement mortar lining of the pipeline.
