Denver Water's Assessment of Interior Polyurethane Coating of 108-inch Water Pipeline

John H. Bambei, Jr.¹, Neal Kelemen², Richard Mielke³

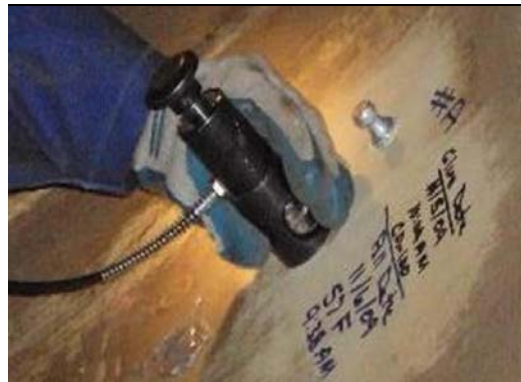
Test Method: The adhesion testing method consists of gluing a small aluminum plug, called a dolly, usually of 20 millimeter diameter, to the abraded polyurethane surface. The other end of the dolly is configured with a knob such that a hydraulic pulling device can be attached as shown in Figure 1. It shows the hydraulic tester being held over an affixed dolly that is partially visible. A second dolly, shown above the gloved hand, has been glued and ready for testing. The hand pump connected by hydraulic line to the tester is to the left and not shown in the picture.

Figure 1: Readings being taken with Hydraulic Tester, Nov. 2009

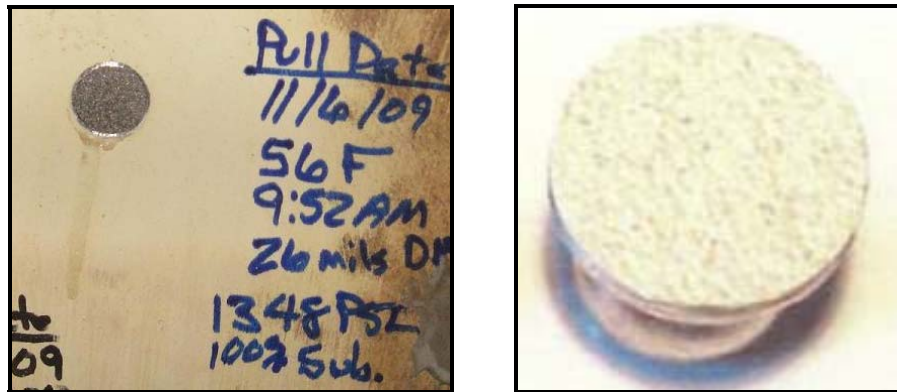
An outcome of the adhesion test process is that a round area of the steel substrate, equal to the diameter of the dolly, is usually exposed. In general, the steel surfaces exposed by adhesion testing of the bypass pipeline were clean, bright, and exhibited a blast profile as shown in Figure 2a. However, closer visual examination under extremely bright light sometimes showed some slight discoloration and orange tint to the steel surface. In examination of the dollies which retained the coating, Figure 2b, the removed underside of the polyurethane that had been in contact with the steel substrate contained small black specks. The specks were not evident on the steel substrate and appeared to be embedded into the coating.

Figure 2a,b: Exposed steel substrate after adhesion pull, MK 171;
Underside of dolly showing embedded material

One possible explanation is that the black specs are residual blast media or other contamination that was not fully cleaned from the pipe surface prior to application of the polyurethane. At the time, the manufacturer used hand blast equipment to prepare the pipe surface. Blasts of compressed air from a hand wand were used to clear the blast media from the pipe wall surface prior to spray application. As this was the manufacturer's first project with polyurethane interior coating for pipe, sufficient steps to adequately clean the pipe surface may not have been taken. Much more stringent protocols are followed today to ensure a clean pipe surface prior to coating application.

In order to learn more about the deposits embedded in the polyurethane, Denver Water sent the dollies to separate laboratories in 2006 and 2009⁷. Scanning electron microscopy (SEM) and energy dispersive spectroscopy (EDS) was performed on debris dislodged from the polyurethane. Both laboratories confirmed that the material was composed largely of iron oxide and hydroxide products, with much smaller quantities of other trace elements present. As polyurethane is not completely impervious to moisture, some transmission of water to the underlying steel surface possibly occurs in a fully immersed coating environment. The oxygen in the water could react with iron elements, producing a corrosion byproduct such as the deposits found embedded in the polyurethane underside. To the extent the oxygen is depleted and not replenished, active corrosion under the polyurethane surface is likely very

minor and short lived. The amount of debris varied by dolly, but no correlation could be established between adhesion value and what was found embedded in the polyurethane.
