## San Diego County Water Authority Aqueduct Protection Program since 1992: Evolution in Design and Construction of Steel Cylinder Relining of PCCP

Michael K. Kenny<sup>1</sup>, Shah Rahman<sup>2</sup>

### ABSTRACT

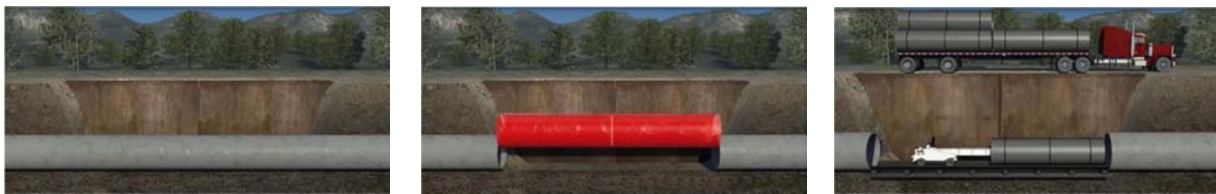
Figures 1a, b, c: Portal Excavation, Removal of 2 PCCP sections, Transport of Reliners into Pipe

**Relining Process:** Rahman et al. (2012) provide a brief overview of the collapsed steel cylinder relining process. PCCP relining begins with gaining access to the host PCCP line by excavating portals approximately 100-ft by 40-ft, depending on whether they're shored with steel plates or sloped excavations, Figure 1a. This is followed by the permanent removal of two 20-ft sections of PCCP, giving access to the host pipe in either direction from the portal, Figure 1b. Pipe carrier carts, usually proprietary to the installation contractor, are then used to transport the collapsed steel reliners which are bound with steel straps to hold them in a collapsed state, into the host PCCP, Figure 1c.

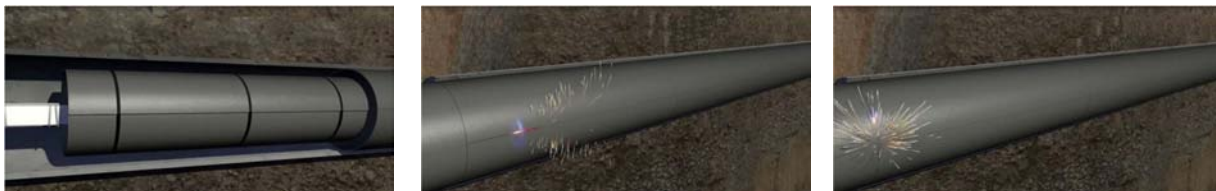
Figures 2a, b, c: Removal of Steel Bands, Full Penetration Longitudinal Seam Welding, Full Fillet Circumferential Joint Welding

As each reliner is placed at the appropriate location in the host pipe, the fit-up of that section, and adjacent sections, begins. Each section is first re-rounded by cutting of the steel straps holding it in its collapsed state, Figure 2a, followed by the use of hydraulic rams and jacks for precision fit-up. Fit-up tolerances are very tight per Water Authority specifications, to ensure the highest quality of installation. Tack welds initially hold the cylinders into place when the specified positions are achieved inside the host PCCP. Permanent welds are then applied in the form of full-penetration welds along the longitudinal seams of the cylinder, Figure 2b, and full fillet welds circumferentially to join the bell-and-spigot joints of adjacent sections of reliners, Figure 2c.

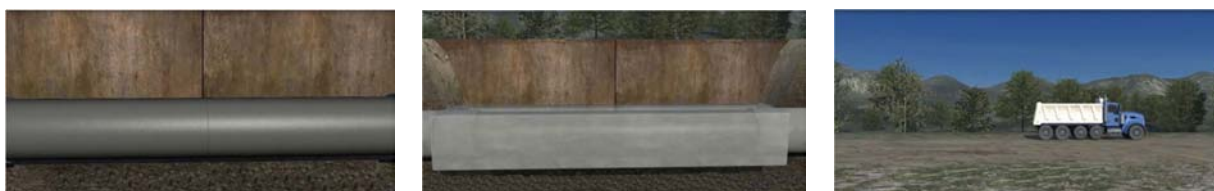
**Figures 3a, b, c: New Steel Pipe Sections Placed at Portal where 2 Sections of PCCP was Removed, Reinforced Steel and Concrete around New Pipe, Portal Backfilled**

are installed periodically by welding to the host PCCP Carnegie rings at joints during fit-up; these grout rings serve as grout bulkheads, partitioning off the annular space into sections, which then serve to control external grouting pressures. After the grouting operation, grout plugs secure the ports. Internal corrosion protection of the relining system is then provided by in-field application of cement mortar lining using a centripetal spray system. To complete the relining, new steel pipe sections are installed at the portal site, Figure 3a. Reinforced steel and concrete are placed around the new sections of steel pipe, Figure 3b, and the portals are finally backfilled, Figure 3c.

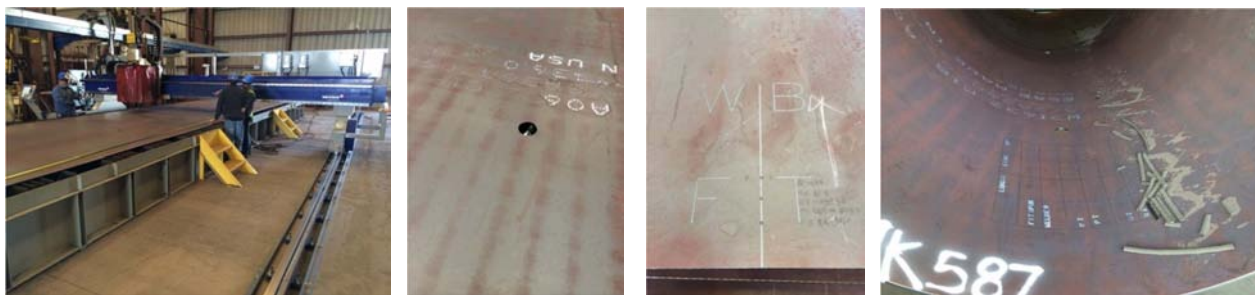
**Figures 4a, b, c, d: Burn Table, Hole Cut for Grout Coupling, Orientation Etch, Grid Etched for Technical Information on Each Reliner Section**

Fabrication of the collapsible relining cylinders begins with the ordering of steel plates by the pipe manufacturer. On the Sweetwater to Lower Otay (Pipeline 3) project, discussed as a case history in the next section, steel plates were ordered to “ASTM A36 Grade 36, modified to have minimum yield strength of 40,000 psi.” Steel plates were first cut to required lengths and widths on a burn table, Figure 4a. The programmable burn table squared the ends of the steel plate, cut holes for grout couplings in assigned locations on the steel plates, Figure 4b, created any required miters, and locations for spacer blocks and back-up bars were marked on the plate using an arc tracer. Other items etched on the surface included orientation of the steel plate, Figure 4c, and grids for placing pertinent technical information on each cylinder, Figure 4d.

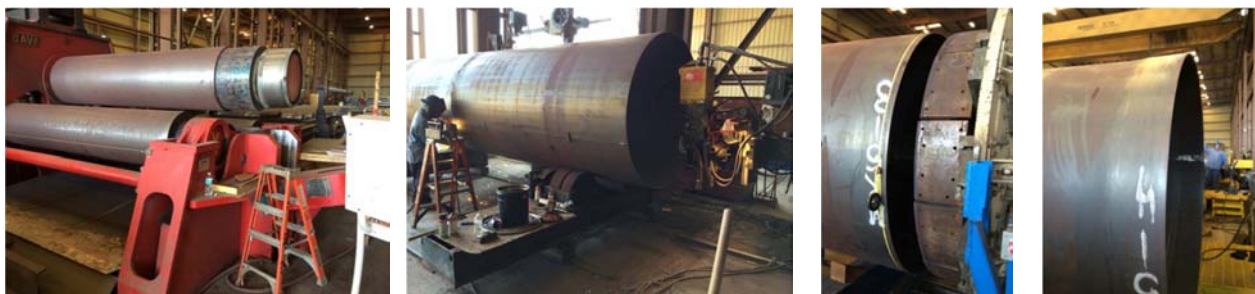
**Figures 5a, b, c, d: Pyramid-type Rollers for Plate Rolling, Girth-seam Welding of two Sections of Reliner, Hydraulic Expander for Belling, Completed Bell**

Plates were then rolled into cylinders of required diameters using a pyramid-type roller, Figure 5a, and tack welds placed along the longitudinal seam to hold the liner into shape. Two pieces of rolled cylinders were then fitted up for girth seam welding, resulting in the specified length of reliner, Figure 5b. Full penetration submerged arc welding was required for all girth seams; all sub-arc welds were required to be either x-rayed or undergo real time radiography. On the end of the cylinder where the weld bell was to be formed, the longitudinal seam was then welded to allow for belling to take place, Figure 5b. A bell was then formed using a hydraulic expander at the end of the cylinder where the seam weld was completed for belling, Figure 5c, and d.

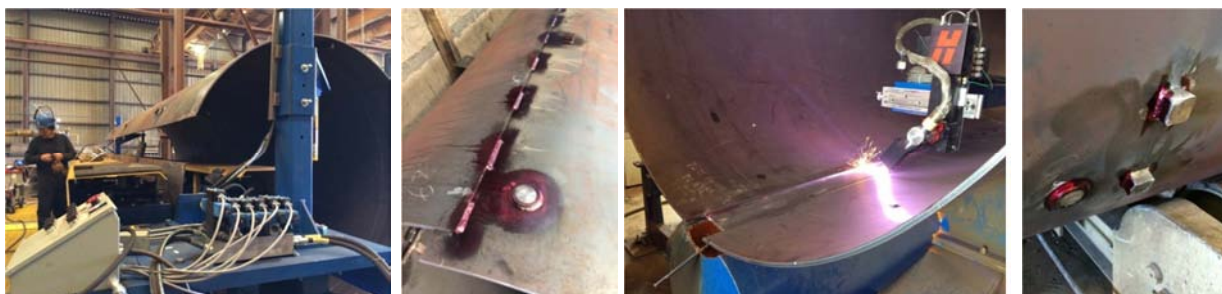
**Figures 6a, b, c, d: Preparation for Backup Bar Forming, Completed Backup-Bar with Dye-Penetrant Testing Complete, Stitch Cutting of Backup Bar Prior to Collapsing, Dye-Penetrant Testing of Welded Spacer Blocks and Grout Couplings**

Backup bars were made at previously etched sections of the plates, Figure 6a, and b; backup bar welds were tested using dye-penetrant. Backup bars were then stitch cut to prepare for the overlapping of the longitudinal seams for the collapsing of the reliners, Figure 6c. Spacer blocks were welded on the reliners, as were grout couplings in the previously cut holes; dye-penetrant testing was completed on each welded item, Figure 6d.

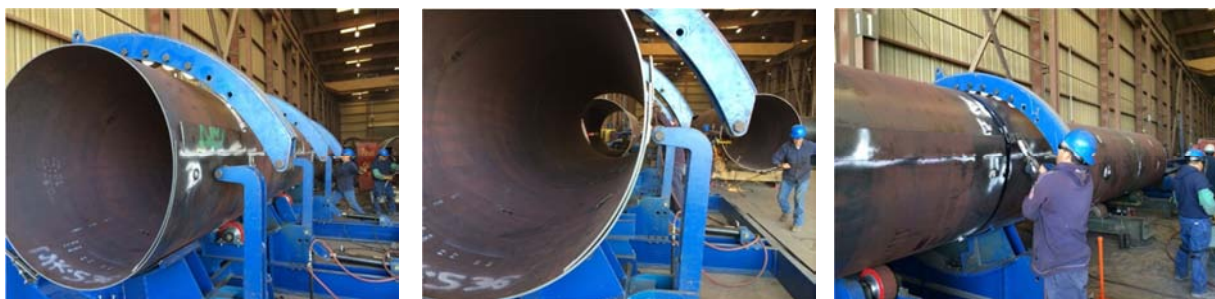
**Figures 7a, b, c: New Steel Pipe Sections Placed at Portal where 2 Sections of PCCP was Removed, Reinforced Steel and Concrete around New Pipe, Portal Backfilled**

The final steps included collapsing the cylinders, Figure 7a, tie bars being welded internally, Figure 7b, and steel straps placed around the outside to ensure that the liner would remain in the collapsed state, Figure 7c, until re-rounded in the field by removal of both the steel straps and the tie bars during installation. Steel liners were now ready for storage and transportation to the project site.

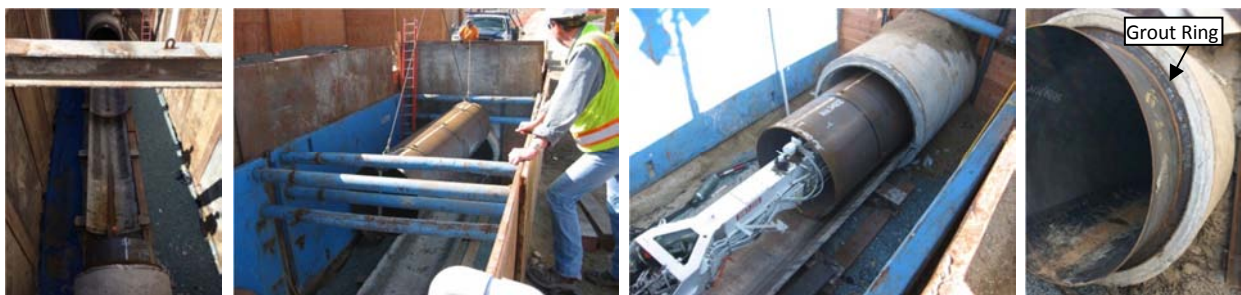
Figures 9a, b, c, d: Portal with 2 Sections of Host PCCP Removed, Steel Reliner being Lowered into Portal, Insertion of Reliner Section into Host Line on Pipe Carrier Cart, Installed Grout Ring

The process utilized for this relining project was essentially performed as described previously in this paper. 11 full size portals were made to enable the removal of 40-ft, or two sections of the host PCCP, Figure 9a. Once reliners were lowered into the portal, Figure 9b, removal

of the two sections of pipe facilitated man-entry into the host pipe as well as insertion of collapsed steel reliners, Figure 9c. Full size portals were located at points 1, 3, 4, 5, 7, 8, 10, 12, 14, 16 and 17, shown in Figure 8a.

Welders were able to fit up and weld up to 700-ft of reliners/day. For the 20-ft sections of reliners, about a dozen tack welds were placed longitudinally and circumferentially as part of the fit-up process. Based on grout density and the use of 14-ft lift heights, the number of grout rings (means by which grouting pressure is controlled to prevent buckling of steel cylinders), which was originally numbered at 290 for the entire project, was cut in half. This directly affected installation productivity rates since subsequent liner installations beyond a ring must wait until grout rings have been fit up, welded and tested using dye penetrant. Figure 9d shows a grout ring in place.
