## Long Term Weathering Effects on Aromatic Polyurethane Coated Pipe

Stuart G. Croll, PhD<sup>1</sup>, Graham E.C. Bell, PhD, PE<sup>2</sup>, Brent D. Keil, PE<sup>3</sup>

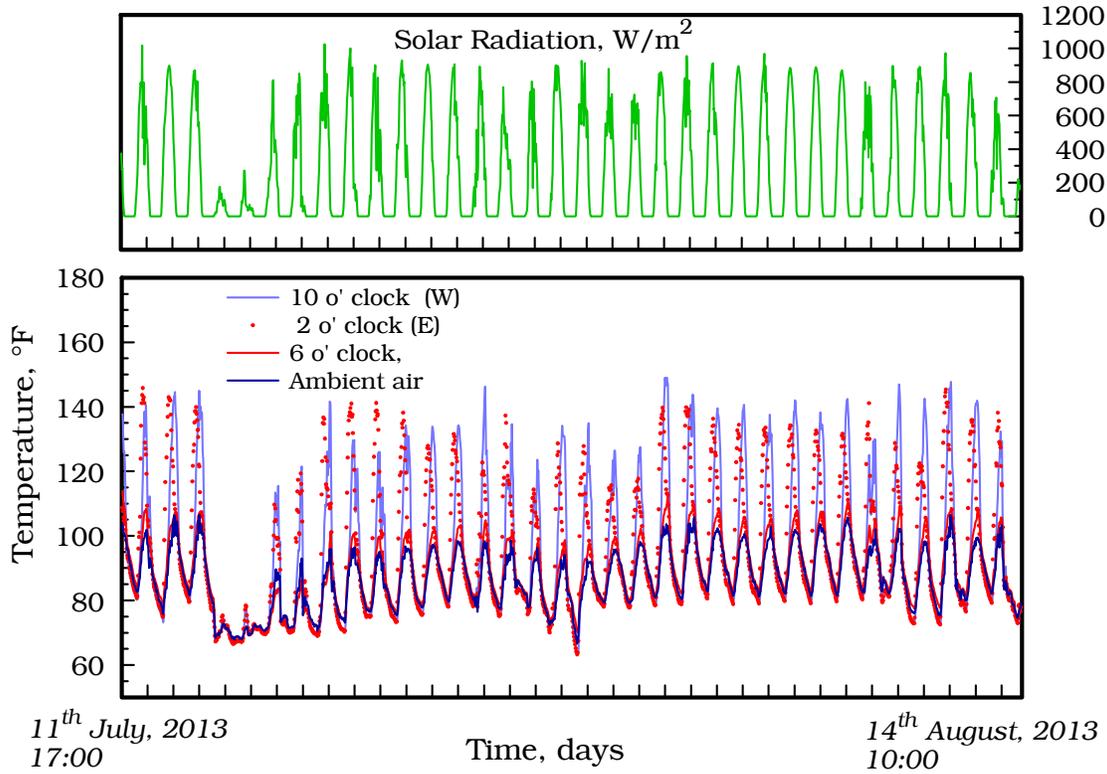
In order to investigate the effect of UV, moisture and heat, a set of test samples of polyurethane coatings were placed in laboratory accelerated weathering exposure for 4 weeks. Another set of samples were cut in June 2013 from a 96" diameter polyurethane coated steel pipe section that had remained exposed in Texas, in hot sunlight. The pipe section has remained stored in the open, since July 2011. Figure 1 shows that temperature sensors placed on the pipe indicated that some parts of the pipes reached 145 °F (63 °C).

Figure 1. Pipe temperature, and Solar radiation, Saginaw Texas, July to August 2013

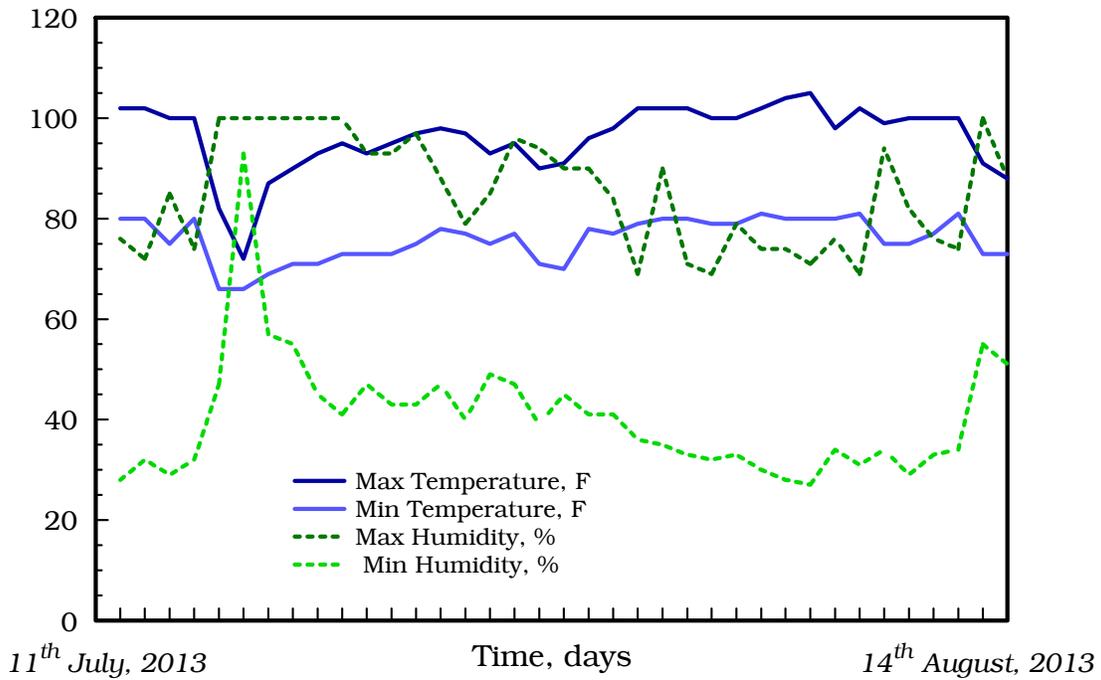
Figure 2. Ambient temperature and humidity readings from neighboring Meacham International Airport, in Fort Worth

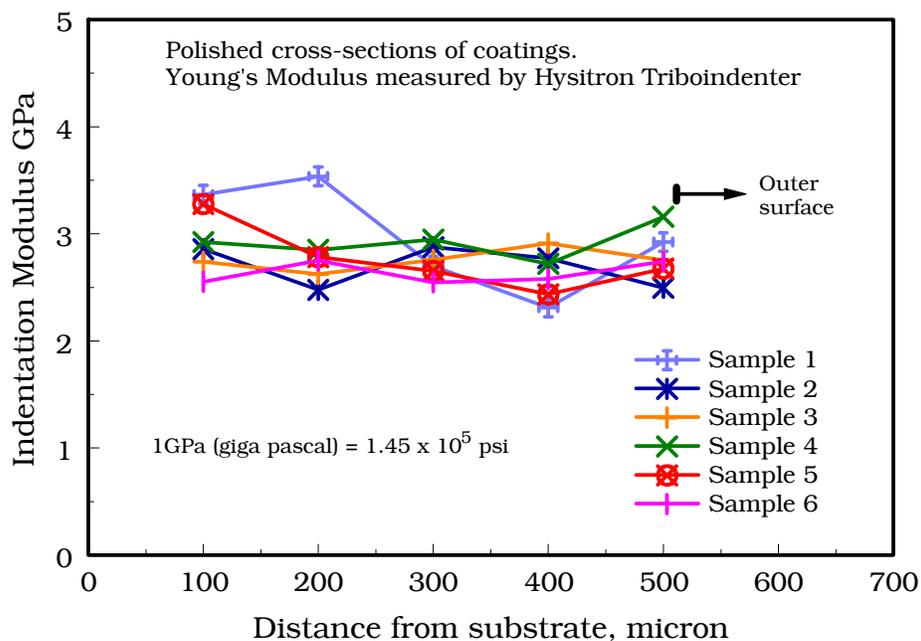
Nanoindentation measurements were done on the polished cross-section of the coatings using a Hysitron Triboindenter®. They showed that the tensile (Young's) modulus through the depth of the coatings (6 samples) remained at levels typical of intact coatings, see Figure 3, except close (within 100 microns) to the outer surface. The modulus at the very outer edge was difficult to measure because locating the nanoindenter tip at a precise distance from the coating surface could not be achieved and the polished surface was not so smooth near the outer surface. However, attempted measurements indicate that there is a reduction in modulus within 50 micron (2 mil), to around 1 GPa (giga pascal) or less.

Figure 3. Nanoindentation results for modulus through thickness of coating.

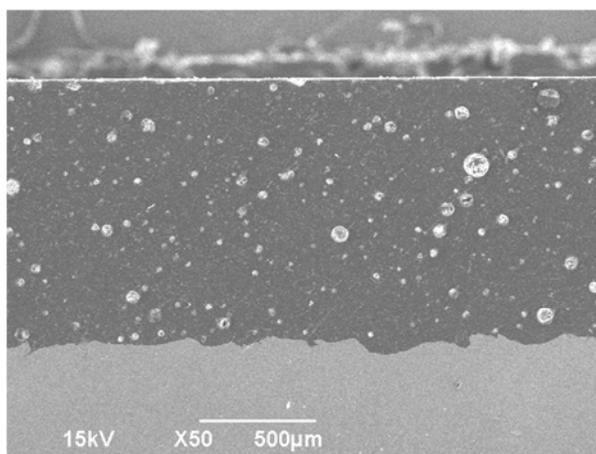
Figure 4. Degraded sample #1 from near pipe summit. General view of entire coating thickness, from steel (bottom) to outer surface

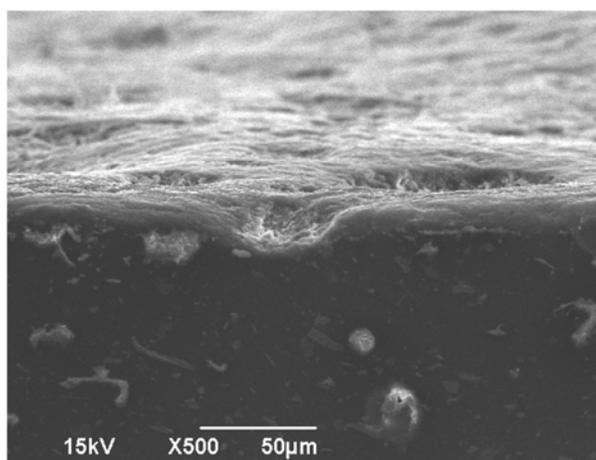
Figure 5. Degraded sample #1, higher magnification of outer surface

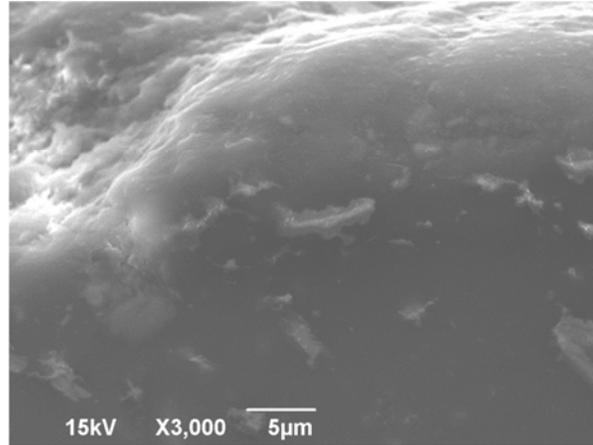
Figure 6. Degraded sample #1, outer surface

Figure 6 shows that there is a layer approximately 5-10  $\mu\text{m}$  deep at the outer surface that is slightly different and may represent the depth of degradation into the coating. However, it is not uncommon for coatings to have different, more surface active composition near the interface with air (see comment above).

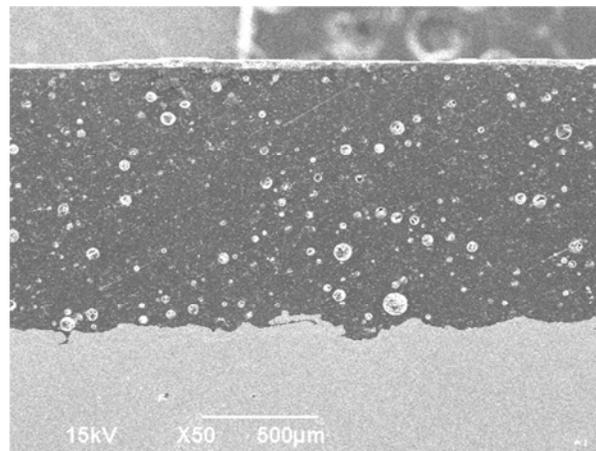
Figure 7. Protected sample #3 from shaded pipe bottom. General view of entire coating thickness, from steel (bottom) to outer surface

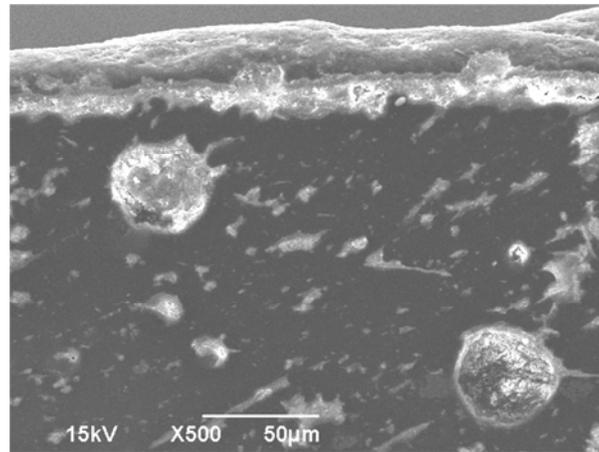
Figure 8. Protected sample #3, higher magnification of outer surface

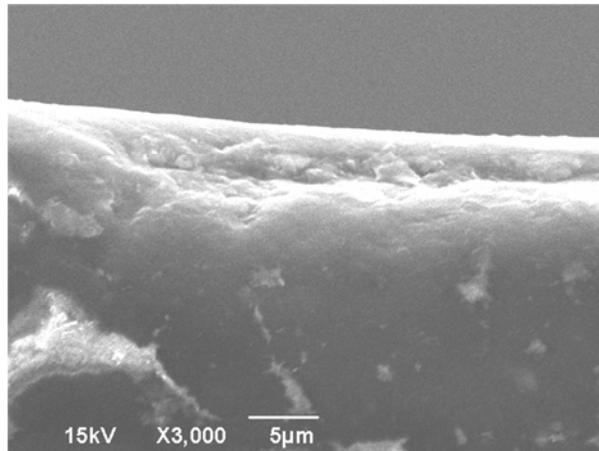
Figure 9. Protected sample #1, outer surface
