Gloss and Color Changes during Exposure of Polyurethane Coatings for Steel Water Pipes and Their Possible Link to Long-Term Corrosion Protection

Stuart Croll¹; Chunju Gu²; Vinod Upadhyay³; and Brent Keil⁴

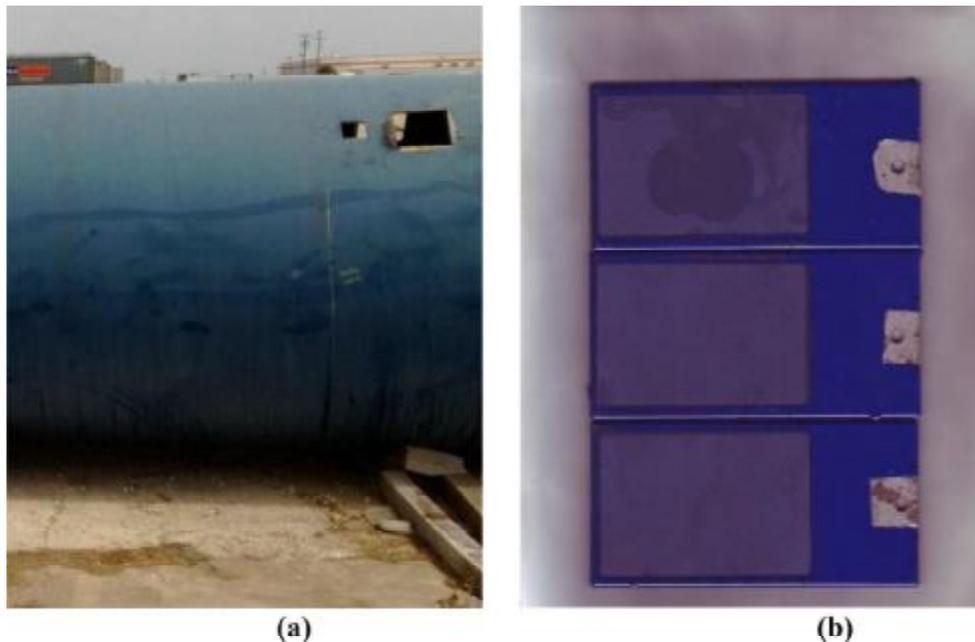
Figure 1. (a) Section of coated pipe, originally dark blue, after 2 years storage in Texas. The top has lost gloss and changed color but, in the shade, the bottom has retained its appearance, (b) coated steel panels after 3 months of accelerated, QUV, weathering. The exposed area has changed but the ends and edges, where the coating was shielded, have not.

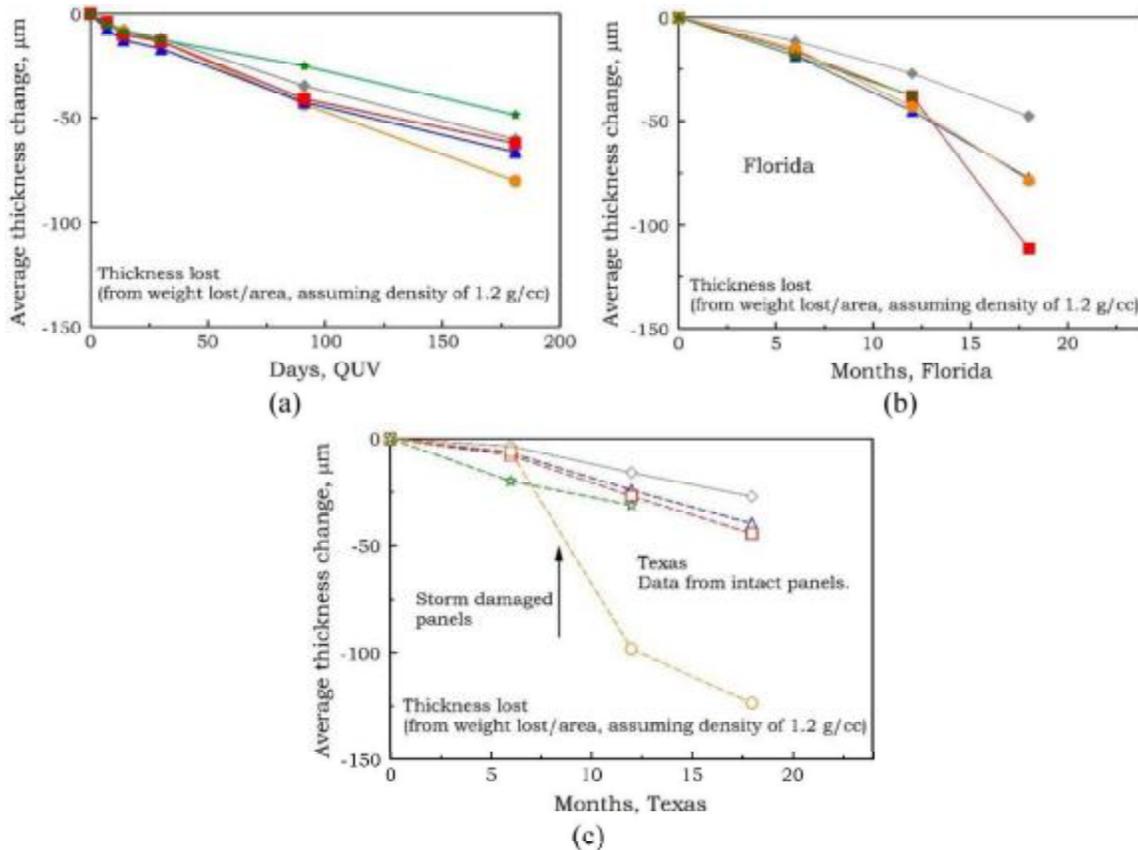
Figure 2. Thickness reduction with time, (a) accelerated, QUV, exposure, (b) Florida exposure, (c) Texas exposure. The results from Texas show when samples were damaged during exposure.

The graphs indicate that the thickness reduction is indeed approximately linear, although the data from natural exposures is more prone to experimental variations due to accidents and methods of dirt removal.

Equation 2 which predicts that gloss diminishes exponentially with exposure time (in simple cases). Gloss measured at 60 or 85 degrees is influenced strongly by shadowing and masking [Bourlier 2002] due to application surface texture, but the gloss loss measured at 20 degrees can be used to test Equation 2. Figure 3 shows the gloss reduction measured under the same circumstances as the weight loss in Figure 2.

Gloss is diminished greatly as soon as the surface height deviations, i.e. roughness, becomes comparable to the wavelength of light (wavelength of green light is 560 nm). It is clear from Figure 2 that material loss continues throughout the exposure and so the material may be losing its protective capabilities, although the gloss does not change further.

Quantifying the degradation of a coating by its appearance is a natural and convenient approach. However, both gloss and yellowing of these aromatic polyurethanes change very quickly and then cease to exhibit any change after a very brief exposure, but we can see that mass continues to be eroded, Figure 2, as the exposure continues. Thus there are grounds for concern over the corrosion protective qualities of the coatings, which are designed to be barriers by virtue of their thickness so that water and salts cannot penetrate and corrode the pipe underneath.

somewhat thinner, as quantified in Figure 2 which shows that they might lose 50 μm after 18 months in Florida or 30 μm after 18 months in Texas. This is approximately 5% of the thickness of the coatings, so that the impedance of the coatings would be similarly reduced. The EIS impedance of two of the coatings, as examples (they are all very similar), after 18 months in both Florida and Texas is shown in Figure 6 with their initial impedance for comparison. There is no perceptible change either between initial and exposed materials, or between several exposed samples of the same formulation.

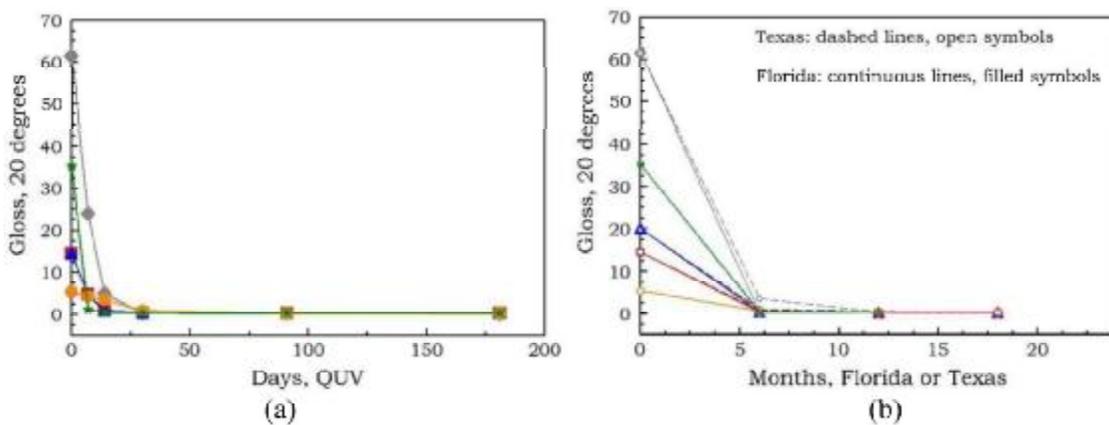
Figure 3. 20 degree gloss loss with time, (a) accelerated, QUV, exposure, (b) Florida and Texas exposures (together).

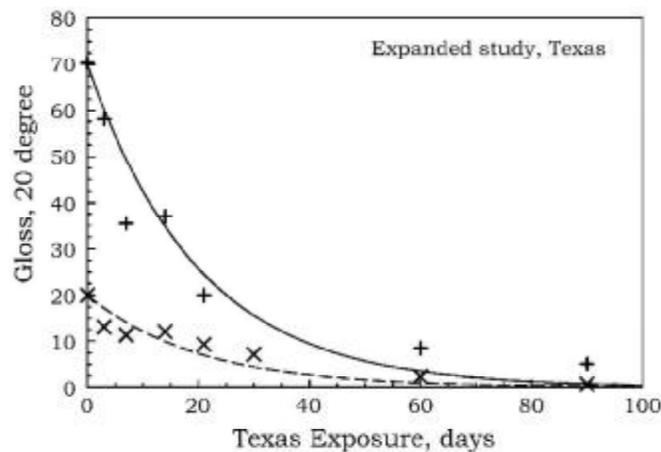
In these exposures, gloss loss happens very quickly so there are too few data to test whether the curves are genuinely exponential. However, the expanded exposure series conducted at the Texas site provides a better opportunity, see Figure 4. The curves on the graphs are simple exponentials where both have the same time constant, τ , of 20 days.

Figure 4. Gloss loss, at 20 degrees, of two coating formulations during exposure in Texas. The continuous curves are simple exponentials with the same time constant of 20 days.

The time constant of 20 days is very short compared to the first weathering increment initially used in both Florida and Texas and demonstrates why the initial program of exposures was not discriminating. Unfortunately, continued degradation cannot be monitored by gloss loss since it had decreased to zero. While continued material loss can be used to calculate gloss (although it predicts zero gloss), the very low value of gloss cannot be used to calculate material loss reliably.

Taking a typical thickness loss in Texas to be 30 μm over 6 months and comparing that to the time constant of 20 days for gloss loss, provided that the characteristic size, ε , is the same in both cases, some simple arithmetic shows that the value of ε that satisfies both behaviors at the same time is approximately 0.7 nm. This seems reasonable for the size of a molecular fragment that is lost from the surface of a coating, e.g. by leaching and so one can say that the simple model is plausible.

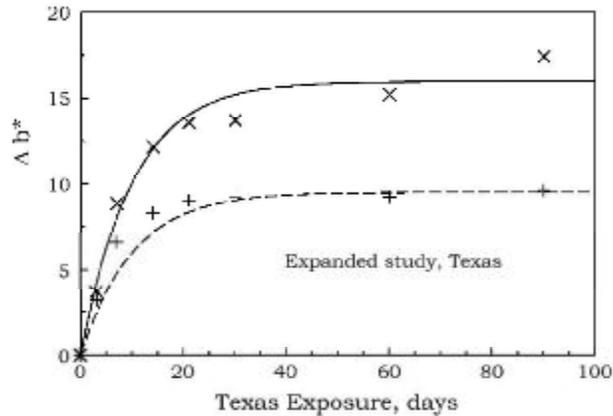
Yellowing with exposure can be quantified using Δb^* , in the Commission internationale de l'éclairage, CIE, $L^*a^*b^*$ coordinates. It occurred even faster than gloss loss in the extended Texas exposure, as has been seen before [Croll 2016] in the artificial weathering and in the natural weathering. The curves on Figure 5 are simple exponential curves:

Figure 5. Increase in yellowing in the expanded Texas exposure. Both curves have a time constant of 10 days.

The starting color in all cases was dark blue, so exposed areas of the coatings became greener as the blue color was adulterated by the yellowing.

At present it is not known whether yellowing can be related to the model for material loss, so Equation 4 is not derived from the earlier model or equation, but used only to better quantify the underlying rate of yellowing. In the extended Texas program the characteristic time constant of the exponential increase in yellowing was 10 days in both cases which is faster than the gloss loss. This is consistent with data published before from this exposure series where again the exposure increments were too large to quantify the comparison. However, the consequence is that yellowing ceases to represent the true state of coating loss, even faster than does gloss.

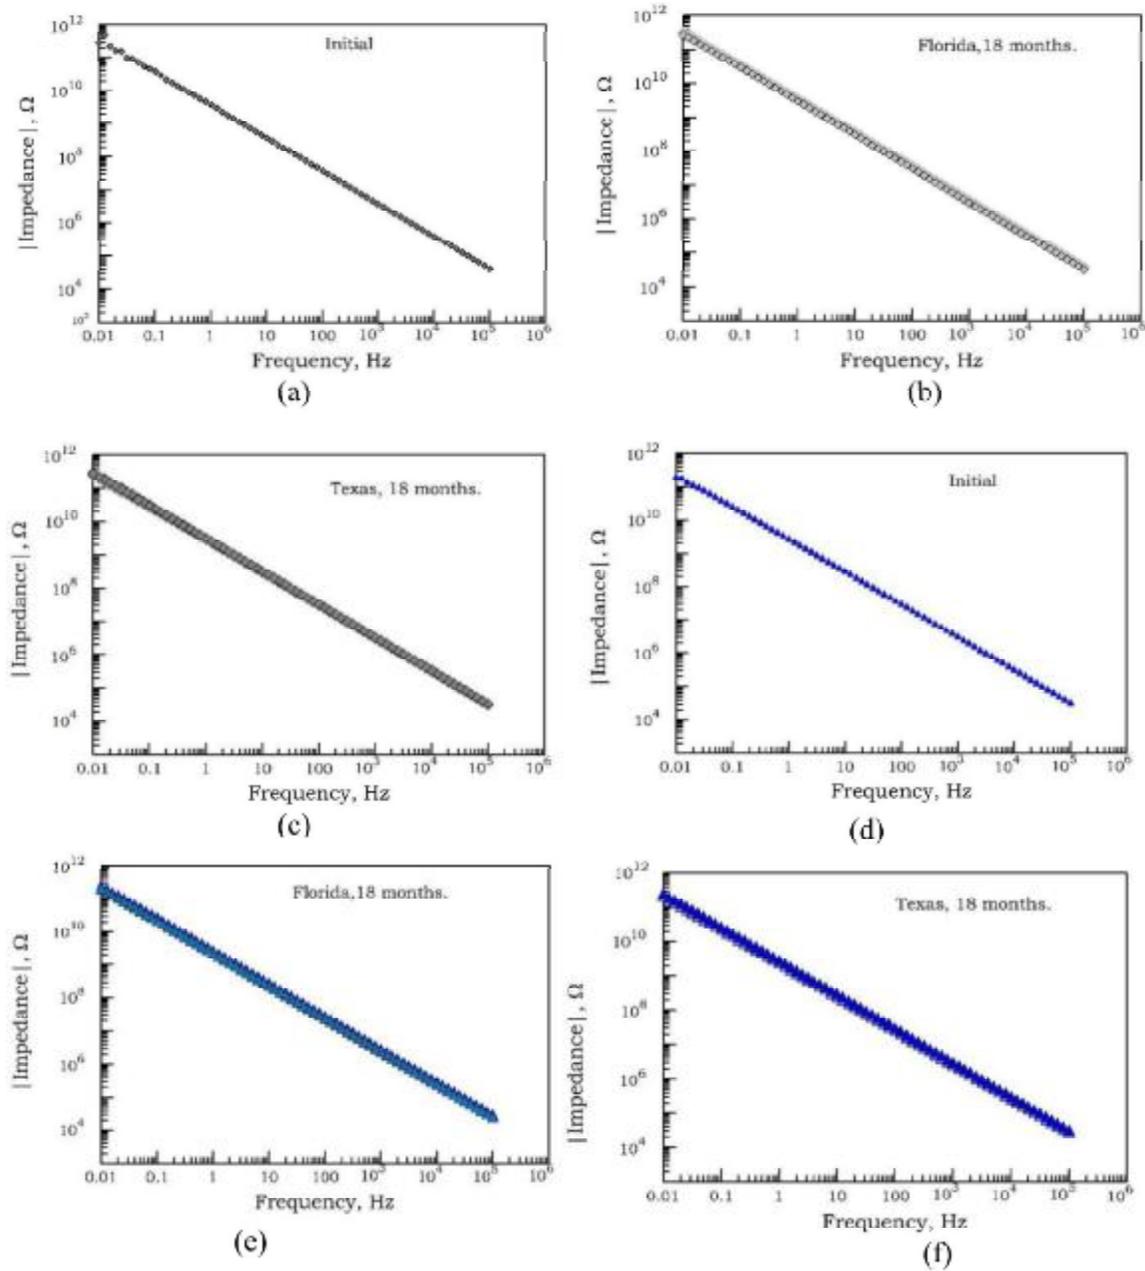
Figure 6. Electrochemical impedance as a function of frequency before and after 18 months exposure. (a), (b) and (c) are results from one coating and (d), (e) and (f) are another example.

These graphs are logarithmic to show all the data that spreads over many decades of frequency. If impedance is reduced by 5% due to loss of thickness, it would not be apparent on these graphs. In addition, from many people's experience, a coating is presumed to remain protective if its impedance is greater than 10^9 ohms at low frequencies. The impedance of all these coatings is approximately two orders of magnitude greater than this. If these coatings fail to provide corrosion performance, it will not be due to overall thickness loss from general degradation when exposed. Failure of the barrier properties is more likely to arise from a defect in the coatings caused either by application or subsequent damage.
