Relining Prestressed Concrete Cylinder Pipe, A Manufacturers Perspective

By Greg Smith and Jeff Bruny
Northwest Pipe Company
12351 Rancho Road
Adelanto, CA
PH (760) 246-3191
FAX (760) 246-2292
Email:jbruny@nwpipe.com

This paper describes the methods of manufacturing and installing the steel liner plates to reline existing PCCP. The project consists of relining sections of a 2438 mm (96in.) and 1753 mm (69in.) pipeline. This paper will describe the unique methods of collapsing the steel cans and the rapid installation requirements required by the owner. Cooperation between the agency, manufacturer, and contractor was essential for the completion of this project on slopes as great as 38 percent. The design and installation of this liner system allowed for a minimum reduction in hydraulic capacity.

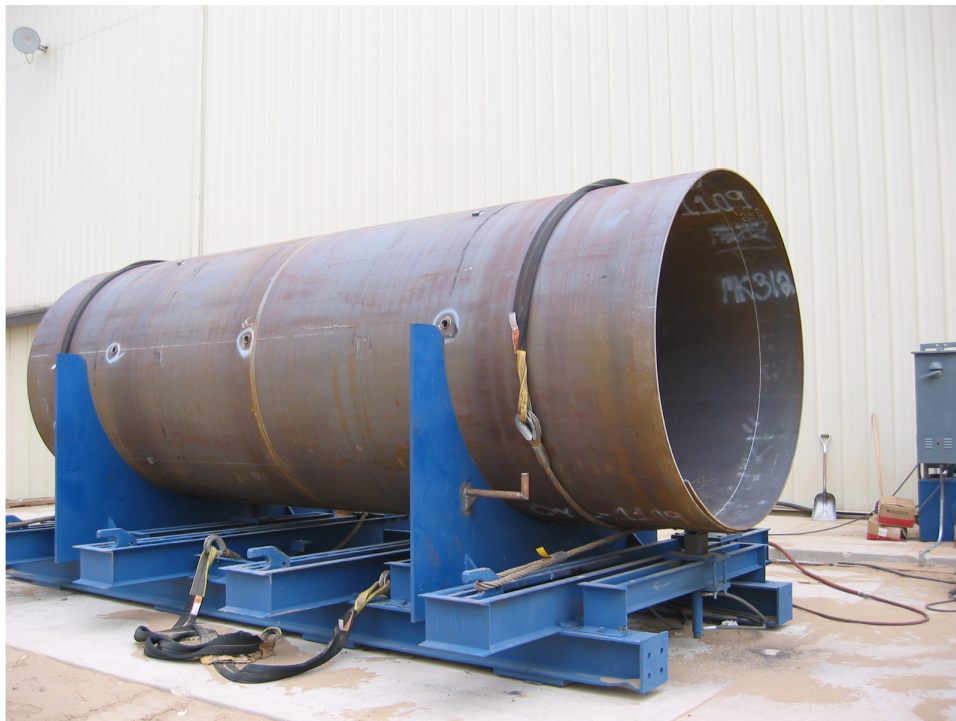
Figure 1. Collapsing Jig

- Weld a 609.6mm(24 inch) seam at the bell end
- Fit and tack two 3m(10 foot) joints to a 6m(20 foot) section
- Miter the ends if required and bell the ends square to the miter
- Weld and test the circumferential weld
- Attach the couplings and spacers
- Cut the section longitudinally and weld back with an 38.1mm(1-1/2") offset
- Cut again longitudinally to create a 76.2cm(3") back up bar the entire length
- Collapse the cylinders to reduce the diameter by 304.8mm(1 foot)
- Install internal tack bars and external banding straps

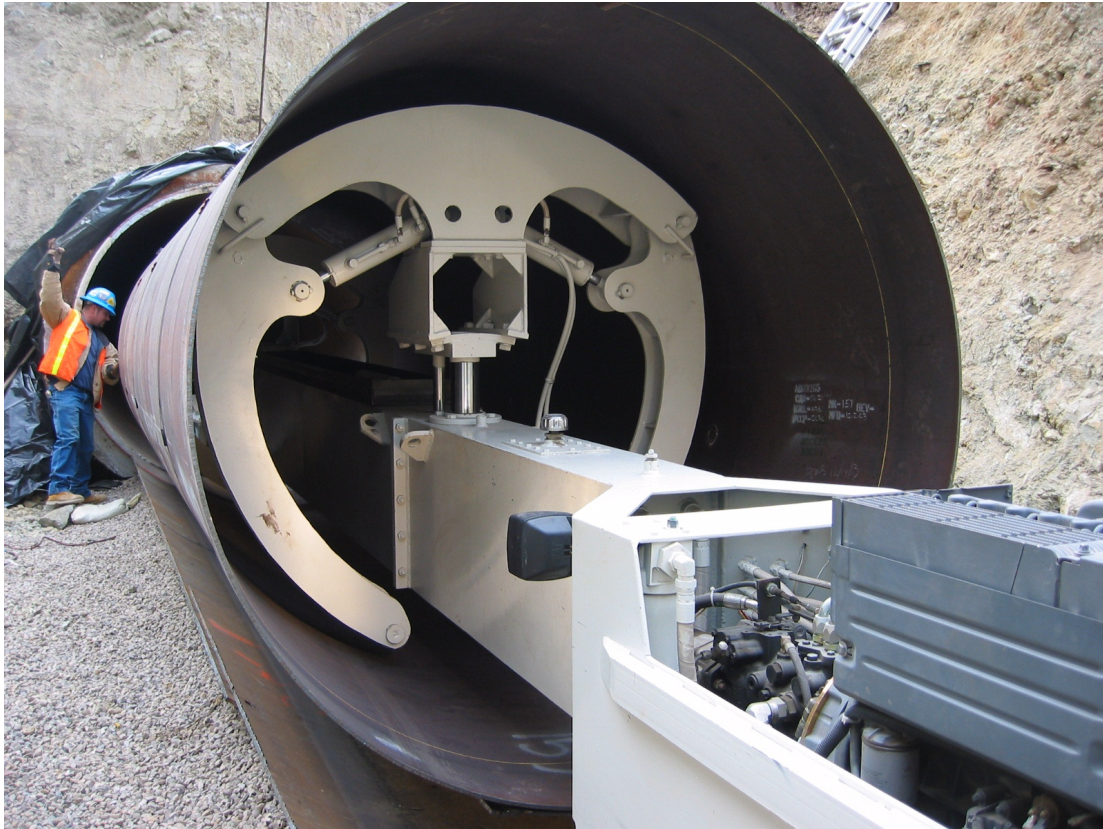
Figure 3. Pipe Carrier transporting liner piece into PCCP

The installation began in early December 2003. Pipe sections were loaded onto custom pipe carriers and transported into the existing pipe to the exact location for installation. It was extremely critical to align the top of pipe into the next section. Pipe were installed spigot into bells with the longitudinal seams off set 152 mm (6 inches) to the adjoining pipe, 76.2 mm (3 inches) either side of center line. A notch was cut into each spigot end's backup bar to facilitate the installation and provide for completed weld geometry at this location. Once the next section was aligned circumferentially and longitudinally, the carrier lifted the pipe to top center and a tack weld was installed at the top of the pipe to

secure it in place. The grout plugs were temporarily removed to expose the banding straps. The tack bars were then broken loose and banding straps cut until the section sprang open with a thunderous bang. Alignment clips and hydraulic jacks were then used to fit the section into the final location. The section was then tack welded along the entire length and circumference. The next section was then ready for placement. This process continued from 7:00 AM to 7:00 PM, Monday through Friday.

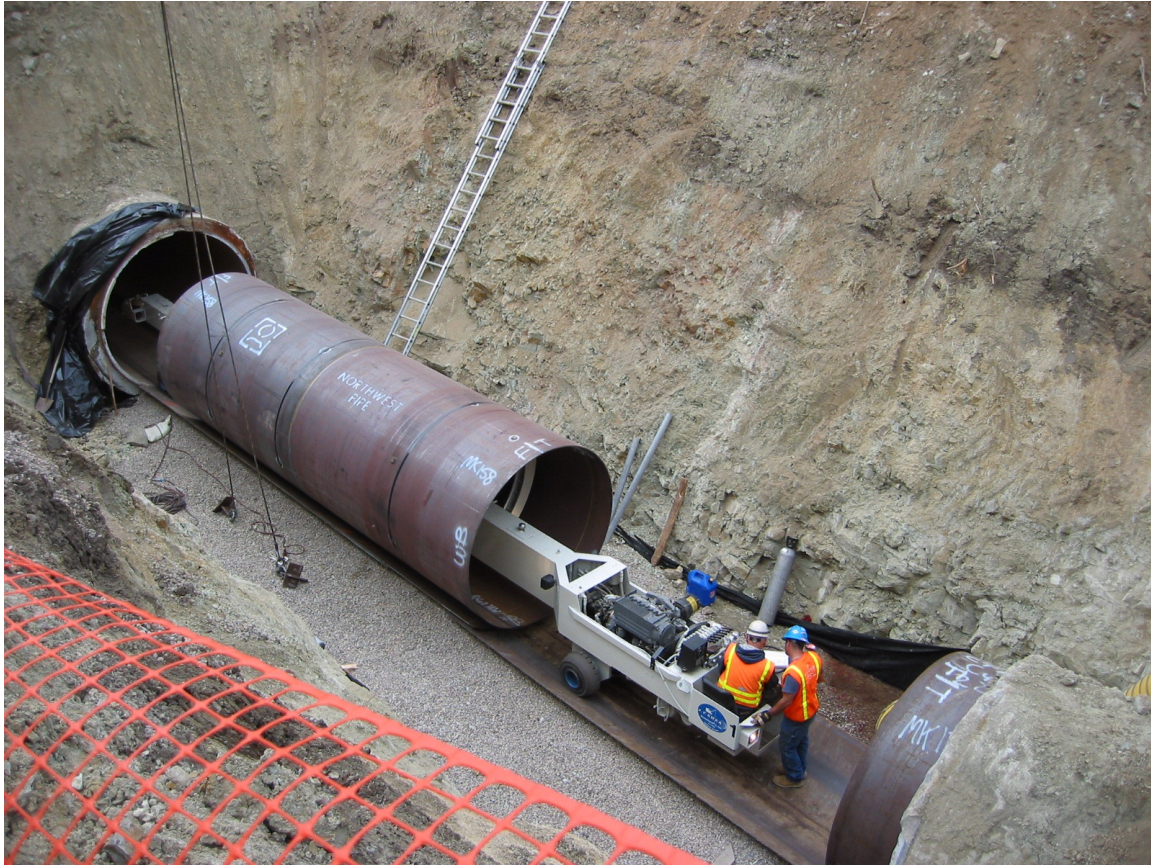
Figure 4. Pipe carrier a portal
