# Steel Water Pipe Joint Testing

By Greg Smith

## Abstract

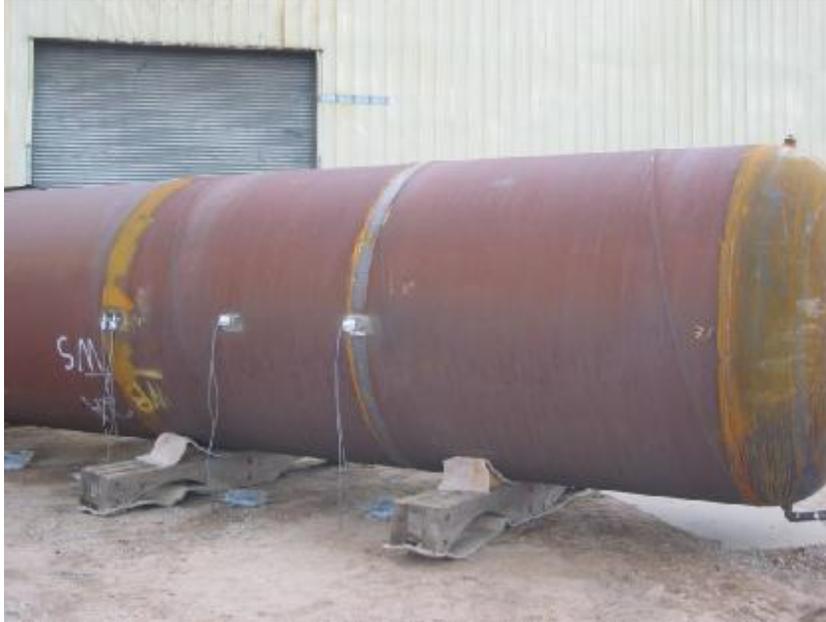
Photo 2

maximum principal stress of the control gauge. After both specimens were tested for internal pressure, the unrestrained specimen was tested by longitudinal compressive loading (simulating a seismic event), to measure performance of joints to one another, as compared to the reference control gauge. See Photo's 2 and 3.

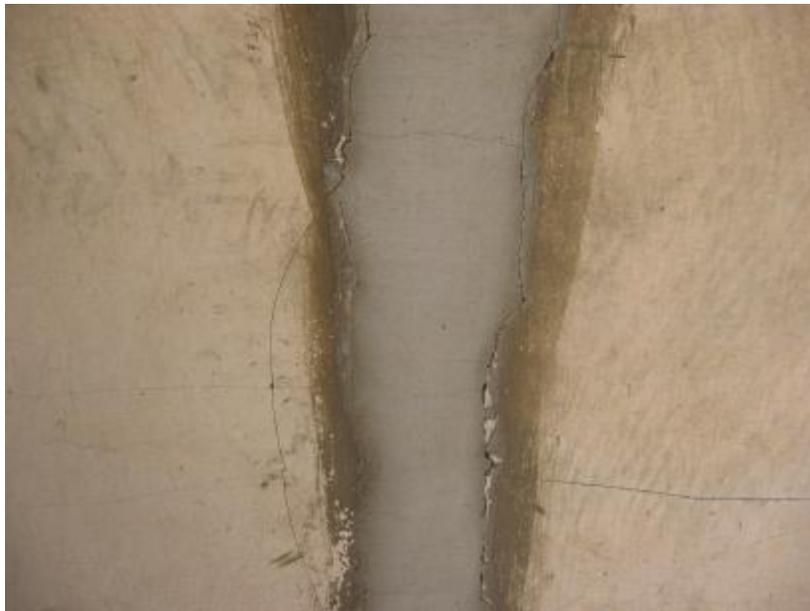
Photo 4

The recorded strain on joint #5 was higher than expected and actually exceeded yield. Close visual inspection revealed some flattening of the bell but no damage to the interior lining. There was no tearing or cracking of the steel or weld that could be visually inspected. The specimen was hydrostatically tested after the collapsing and did not leak when subjected to 300psi internal pressure. The only conclusion from this test was that the weakest joint failed first and due to extreme strains, buckled as predicted and yet retained enough strength to not leak and transfer stress to the other joints. A pipe collapse of this nature would not be performance limiting to a pipeline. See photo 4 and 5. The collapsing testing was performed with no internal pressure, which makes it more
