1. Background

On 6 July 2012, Schlüsselbauer Technology GmbH & Co. KG commissioned the IKT - Institute for Underground Infrastructure for the performance of tests in accordance with the "Registration rules for the selection and use of plastic inner linings for buried waste-water conduits and manholes" issued by the German Institute for Construction Technology (DIBt). The results of the tests for jetting resistance and performance under high-pressure flushing in accordance with DIN 19523 [1] are contained in this report.

The object of testing is the HDPE lining of the "Perfect Pipe Plus" system, which is anchored in the concrete by means of bosses on its rear side.

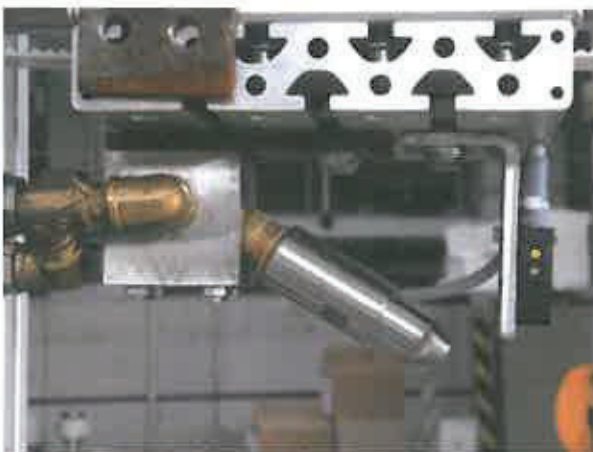
Figure 1: Test nozzle

A test nozzle with a ceramic insert and an aperture diameter of 2.5 mm moving parallel to the longitudinal axis at a distance of 10 (+0/-2) mm from the pipe base was used for the test (see Figure 1 and Figure 2).

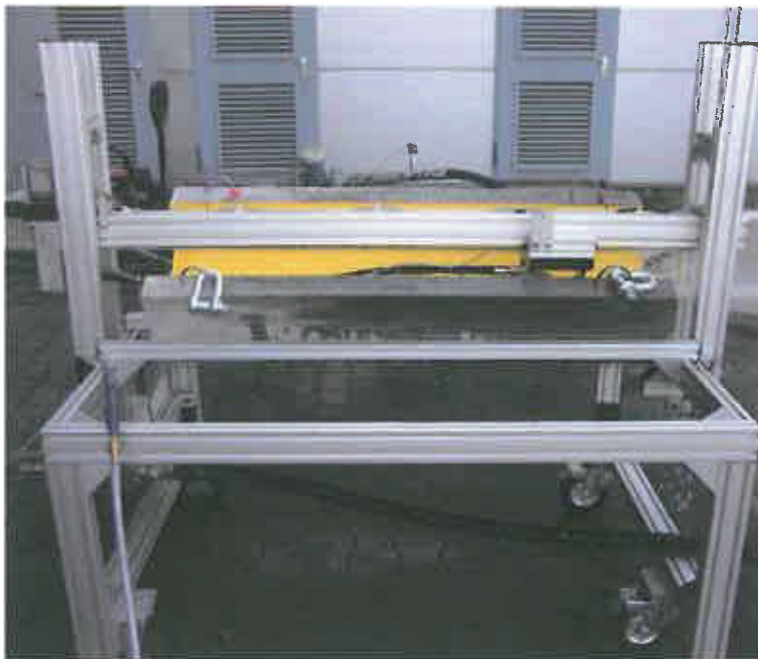
Figure 4: Test apparatus

For this test, three test cycles were performed on each of three test sections. Each cycle consisted of the forward and backward movement of the flushing head across a length of 1.0 m. The test object was visually inspected after completion of each test cycle. The test sections were arranged at lateral intervals of 10 cm from each other.

Water and ambient temperature [°C]:	15 ± 10
Flushing-jet energy density D_j [W/mm ²]:	450 ± 15
Distance of nozzle aperture from pipe base [mm]:	$10 +0 -2$
Flushing head angle α [°]:	30 ± 1
Spread angle of flushing jet ω [°]:	≤ 3.3
Nozzle insert d [mm]:	2.5 ± 0.02
Test-section length [cm]:	130
Test velocity (forward and backward) [m/min]:	0.2 ± 0.02

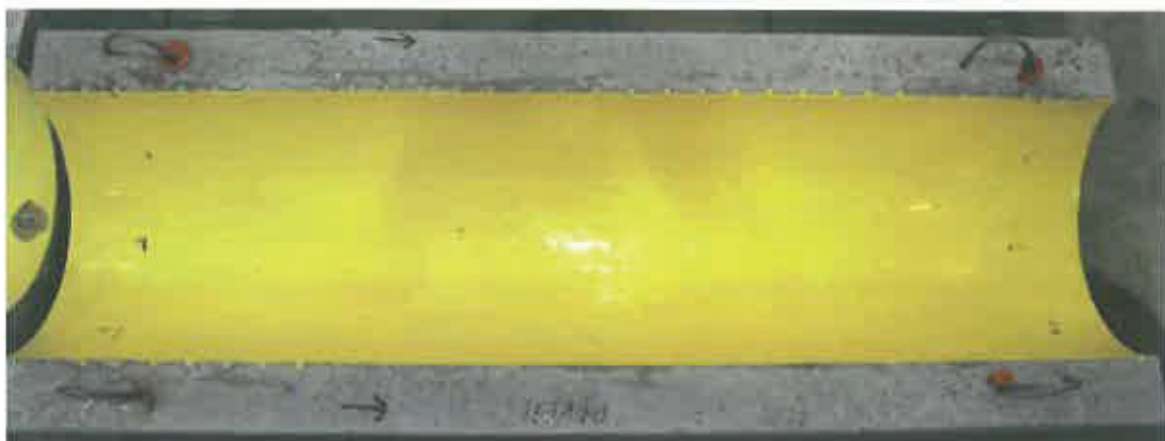
Figure 6: Test Object H2110-1 after the materials test

Prior to the test	Smooth, no damage
After Test Cycle 1	Smooth, no damage
After Test Cycle 2	Smooth, no damage
After Test Cycle 3	Smooth, no damage

The HDPE lining of Schlüsselbauer GmbH & Co. KG's "Perfect Pipe Plus" system passed the test for jetting resistance (materials test) in accordance with DIN 19523.

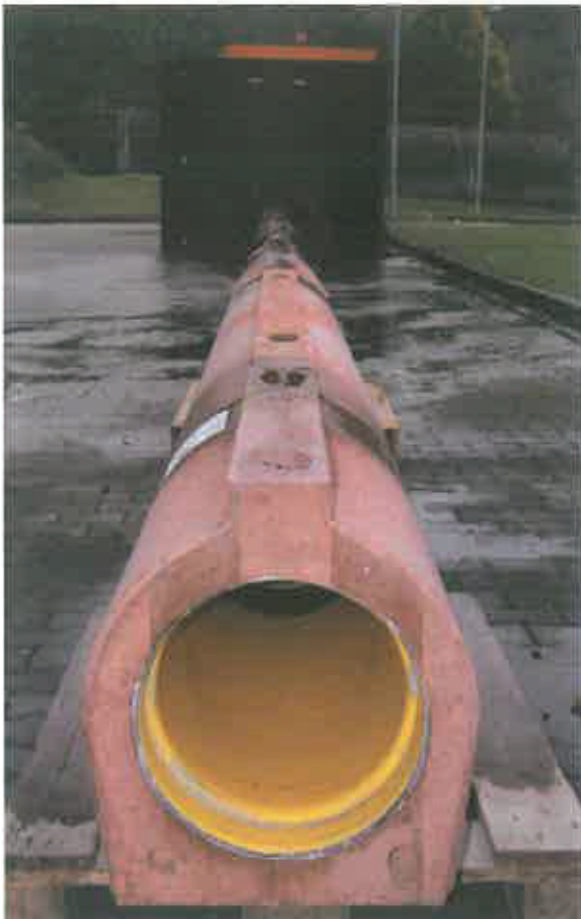
Figure 8: Test apparatus

The high-pressure flushing test is based on DIN 19523, Procedure 2 – Practical test, in which the requirements for performance under high-pressure flushing of pipe materials are defined. Schlüsselbauer GmbH & Co. KG supplied a total of seven DN 300 (2 x 1.0 m and 5 x 3.0 m long) concrete pipes lined with the HDPE Perfect Liner to IKT for the test. The pipe sections were connected together by means of bell joints to form a pipe train of a length of 17 m (see Figure 7 to Figure 9).

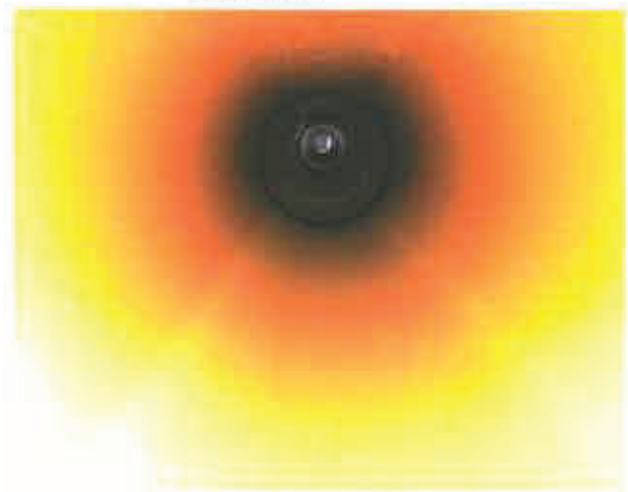
Figure 9: The lining prior to the test

The test section was visually inspected for damage/abnormalities by an IKT employee prior to the start of the test. No visible damage/abnormalities was/were found.

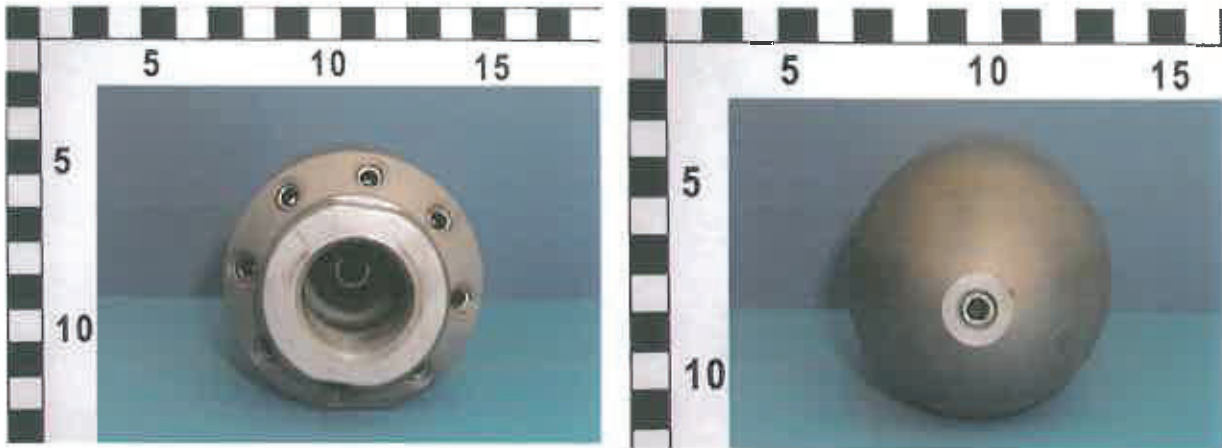
Figure 10: Test nozzle

A total of sixty cleaning cycles were performed during the test; the nozzle was not allowed to remain stationary in the test zone at any time. Each cycle consisted of the forward and backward movement of the nozzle through the entire pipe train. An eight-jet omnidirectional nozzle (see Figure 10) of a length of (17 ± 0.5) cm, a weight of (4.5 ± 0.1) kg and a nozzle-body diameter of (8 ± 0.5) cm was used for these tests.

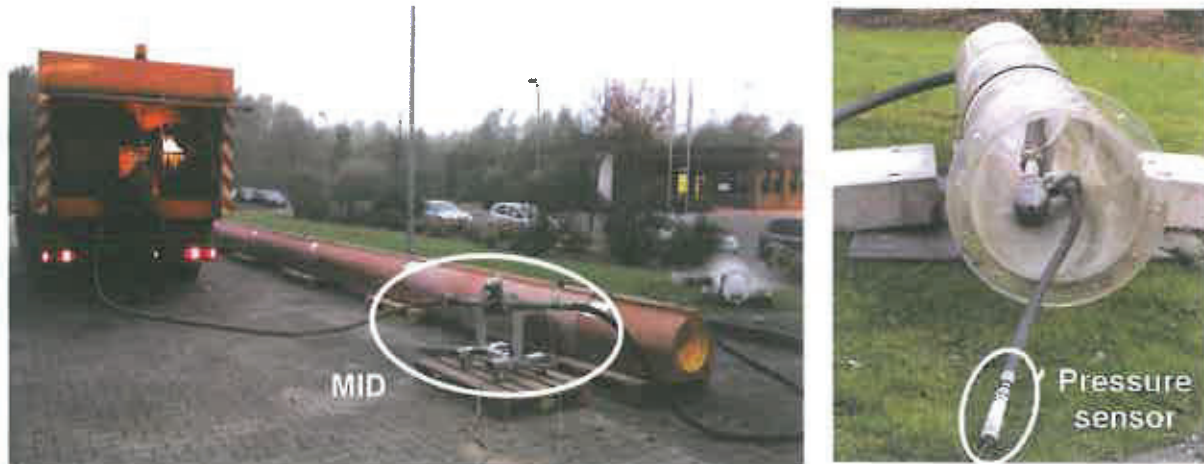
Figure 11: MID and pressure sensor for monitoring of the test parameters

Pressure was determined at a volumetric flow of between 280 l/min and 285 l/min at a distance of not more than 0.1 m from the nozzle body by means of a pressure sensor both before the start and after the conclusion of each test (see Figure 11, right). Volumetric flow was determined by means of a magnetic-inductive flow-measurement system (MID) (see Figure 11, left). The pressure during the test was monitored by means of the pressure gauge on the vehicle.

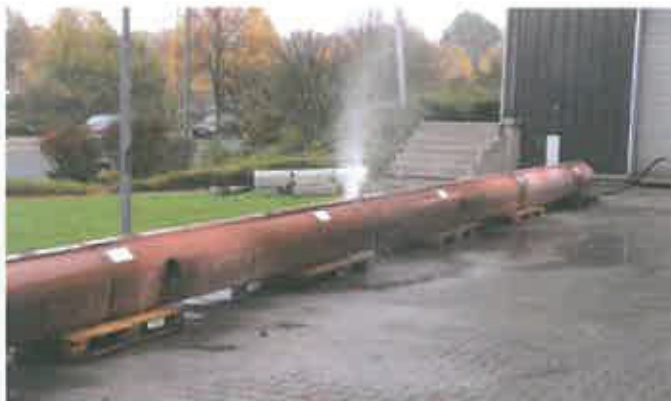
Figure 12: Performance of the test

After determination of the test parameters, the test line was exposed to sixty cleaning cycles (see Figure 12 and Figure 13). The HDPE lining of the "Perfect Pipe Plus" system was then visually inspected.

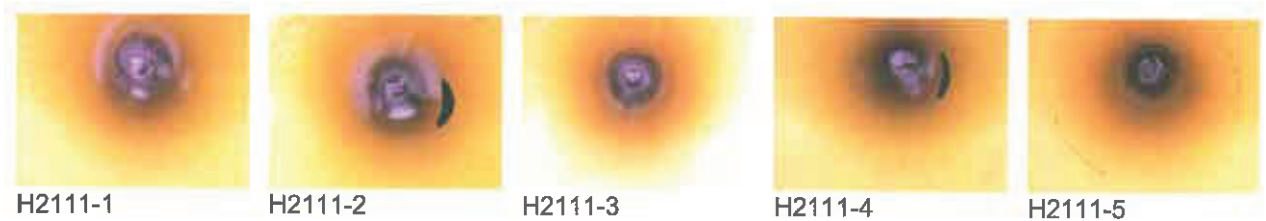
Figure 14: The test object after the practical test

The HDPE lining of the Schlüsselbauer GmbH & Co. KG "Perfect Pipe Plus" system which was tested exhibited no visible abnormalities (damage) (see Figure 14) after exposure to sixty cleaning cycles at a flushing-jet energy density D_j of between 338 W/mm^2 and 341 W/mm^2 and a volumetric flow of between 282.0 l/min and 282.8 l/min and thus passed the test for performance under high-pressure flushing in accordance with DIN 19523.
