**Geneva Pipe
and Precast**
A Northwest Pipe Company

Perfect Lined Manhole Hydrostatic & Vacuum Test Data – SDV Joint

*Hydrostatic and Vacuum joint testing per ASTM requirements on the Perfect Lined Manhole SDV Joint

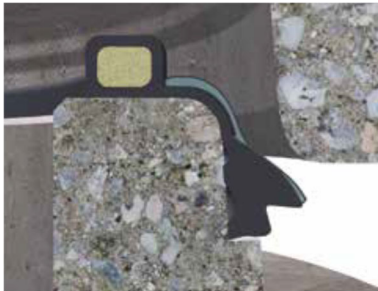
Figure 1: DS SDVseal Cross Section

Joint Component	Qty. Per Joint	Component Description	Purpose
DS SDVseal (see Figure 1)	1	A compression slide ring seal with wedge-shaped cross section and an internally greased closed slide mantel. Connected to the seal is a quartz sand filled load transfer hose.	To seal the manhole joint from infiltration and exfiltration and to transfer the joint load
Liner Clip (see Figure 2)	2	An EPDM rubber clip that is cast into the concrete of the joint and also mechanically attached to the HDPE liner. The Liner Clip is installed on both the bell and spigot of each joint.	To seal the HDPE liner on the interior of the riser to the concrete joint, preventing any exposed concrete

This joint configuration consists of the components described in Table 1 and Figures 1, 2, 3 and 4.

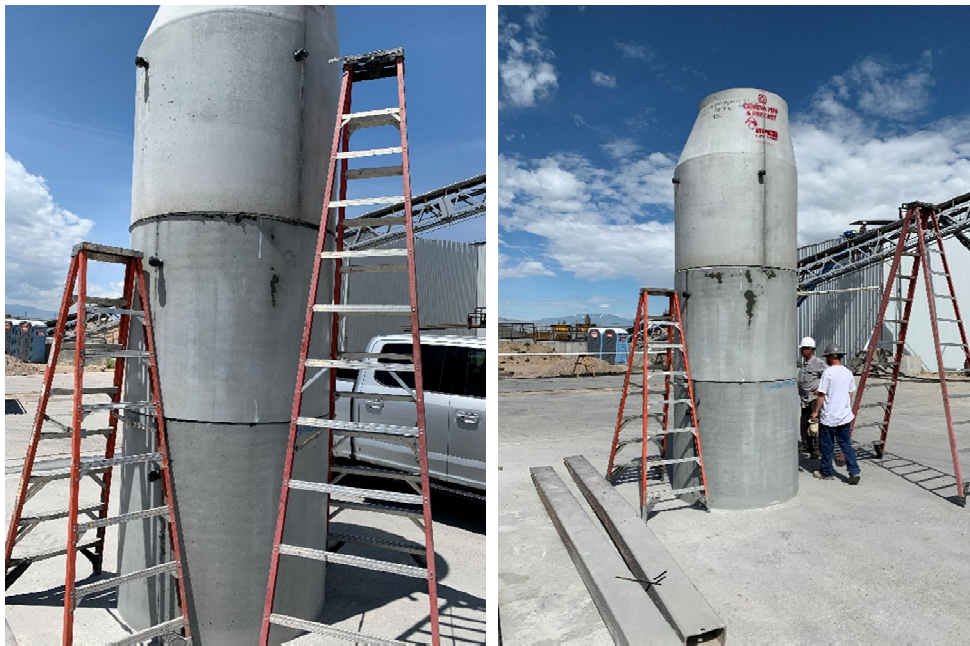
Figure 5: Manhole Stack Image

A lined manhole stack was created. The manhole stack consisted of the components listed in Table 2 from bottom to top. The joint considered for the hydrostatic test was the joint between the manhole base and riser, hereafter referred to as the “base-riser joint”. The base-riser joint for the manhole stack was constructed with the SDV Joint configuration. The hydrostatic test described in the following section was performed on that manhole stack.

Manhole Component	Stack Height (ft.)
48 in. Base	4'
48 in. Riser	4'
48 in. Cone	6'

The manhole stack was filled with water such that the water level reached a total height of 10.25 feet above the base-riser joint. This head of water would result in a total pressure of approximately 4.44 psi on the base-riser joint under consideration. 4.44 psi is equivalent to about 9 in. of mercury which is the passing criteria required for ASTM C1244.

No change in water level was observed in the manhole stack upon visual inspection the next day. Therefore, it was determined that the SDV Joint could maintain a minimum of 4.44 psi over a 20-hour period.

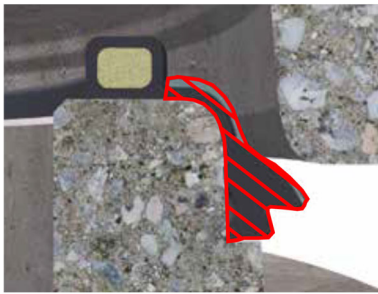
Figure 6: Section of SDV Gasket Removed

Geneva Pipe and Precast's team performed a secondary hydrostatic test in which the lubricated gasket portion of the DS SDVseal gasket was cut off as shown in Figure 6. The purpose of removing this section of the gasket was to test the ability of the quartz sand filled load transfer hose to withstand the exfiltration hydrostatic pressure alone. The same protocol described in the Hydrostatic Test section of this report was conducted with the exception of the manhole stack height. For this secondary test, only the manhole base and cone was stacked as shown in Figure 7. The new manhole stack was filled with water such that the water level reached a total height of 4 feet above the joint. This head of water resulted in a total pressure of approximately 1.73 psi on the joint under consideration. The water was left to sit in the manhole overnight and no signs of leakage were observed the following day, approximately 20 hours later.
