## San Diego County Water Authority Aqueduct Protection Program since 1992: Evolution in Design and Construction of Steel Cylinder Relining of PCCP

Michael K. Kenny<sup>1</sup>, Shah Rahman<sup>2</sup>

### ABSTRACT

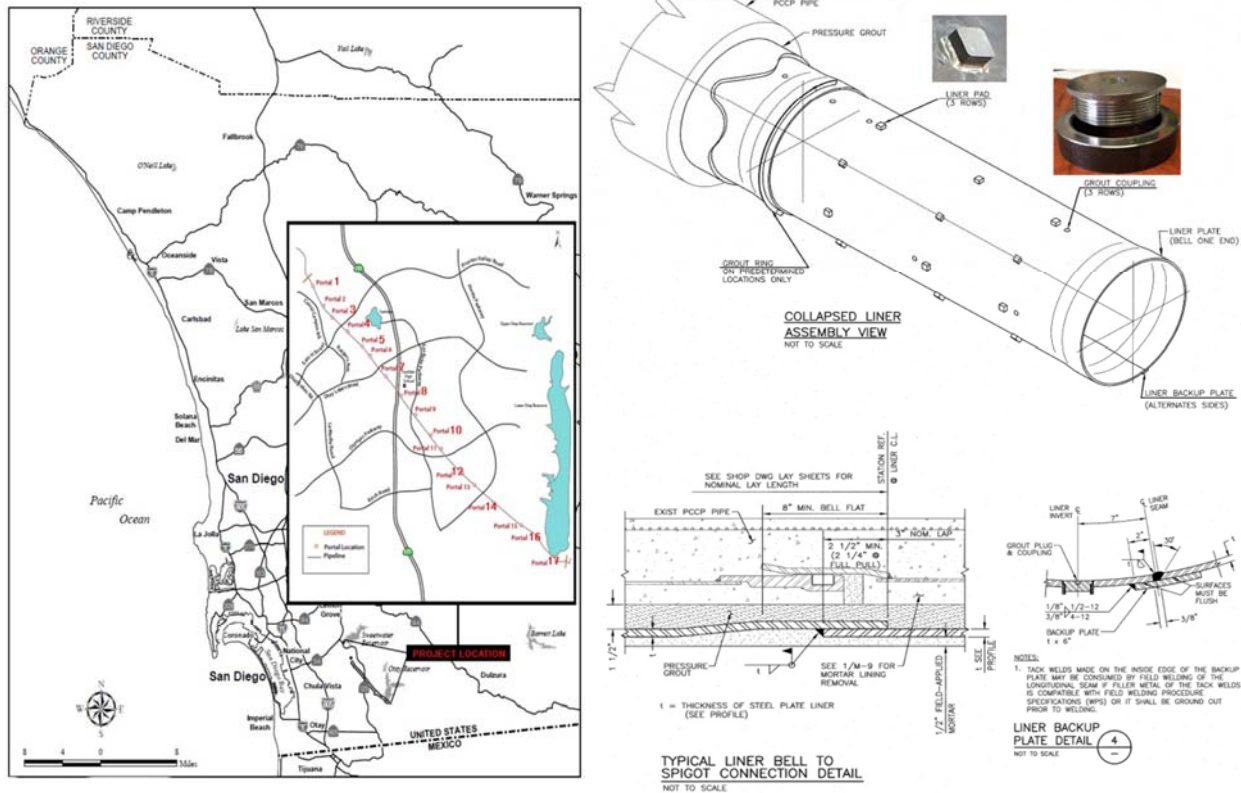
Figure 8a, b: Regional Vicinity Map & Project & Portal Locations, Pertinent Design Details

The Sweetwater to Lower Otay Pipeline Relining Project was awarded in late 2013 to LH Woods and Sons, Inc.; Northwest Pipe Company was the low bidder as the steel relining material supplier. This project involved the structural relining of approximately 5.5 miles of a 69-inch internal diameter PCCP line that traverses portions of the communities of Bonita and eastern Chula Vista (Eastlake, Otay Ranch, as well as the Otay Ranch Preserve and Lower Otay County Park). Figure 8a shows the regional location map, as well as a project vicinity map as an insert, highlighting the pipeline and location of the portals for the relining project. Steel cylinders were manufactured to an outside diameter of 66-inch, and had a wall thickness of 3/8-inch (0.375-inch). While the initial plans were made for 17 entry portals, the Contractor was able to reduce the number of actual portals to 11, without causing any installation problems on the project. The remaining portals served as access shafts, allowing for man and other equipment entry. Figures 8b shows pertinent design details for the steel reliner cylinders on this project.

of the two sections of pipe facilitated man-entry into the host pipe as well as insertion of collapsed steel reliners, Figure 9c. Full size portals were located at points 1, 3, 4, 5, 7, 8, 10, 12, 14, 16 and 17, shown in Figure 8a.
