Changes during the Weathering of Polyurethane Water Pipeline Coatings

S. G. Croll, Ph.D.¹; M. Buratto²; T. Calzone³; C. Gu, Ph.D.¹; D. Robinson⁴;
S. M. Smith⁵; V. Upadhyay, Ph.D.¹; and B. D. Keil, P. E.⁶

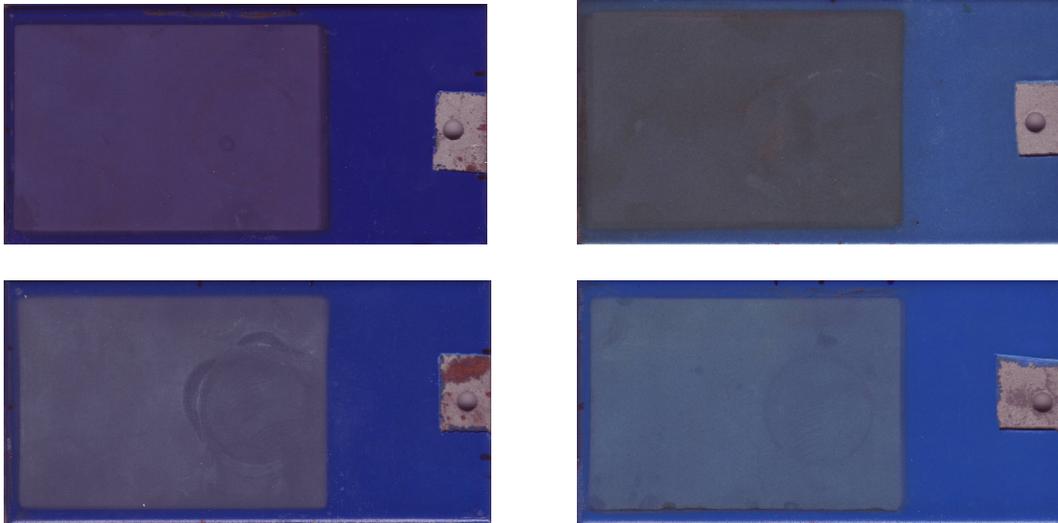
The images below are of a representative sample that had 1 month exposure in the QUV accelerated weathering chamber. The images were made on a flat-bed scanner. The change in color can be seen in each case by comparing the masked regions to the rectangular area towards the left hand side that was exposed. These were panels that were tested with EIS and the size and location of the EIS cell can be discerned. The bare steel area at the right hand side is for making an electrical connection to the metal for EIS, and is taped over while the panel is being exposed.

Figure 1. Images of each of the four coatings on steel panels, showing how appearance has changed after 1 month in QUV. The edges and end are covered by the panel holder (and some tape) during exposure and thus did not degrade.

The initial colors are not identical, but one can see that the changes are visually obvious in each case.

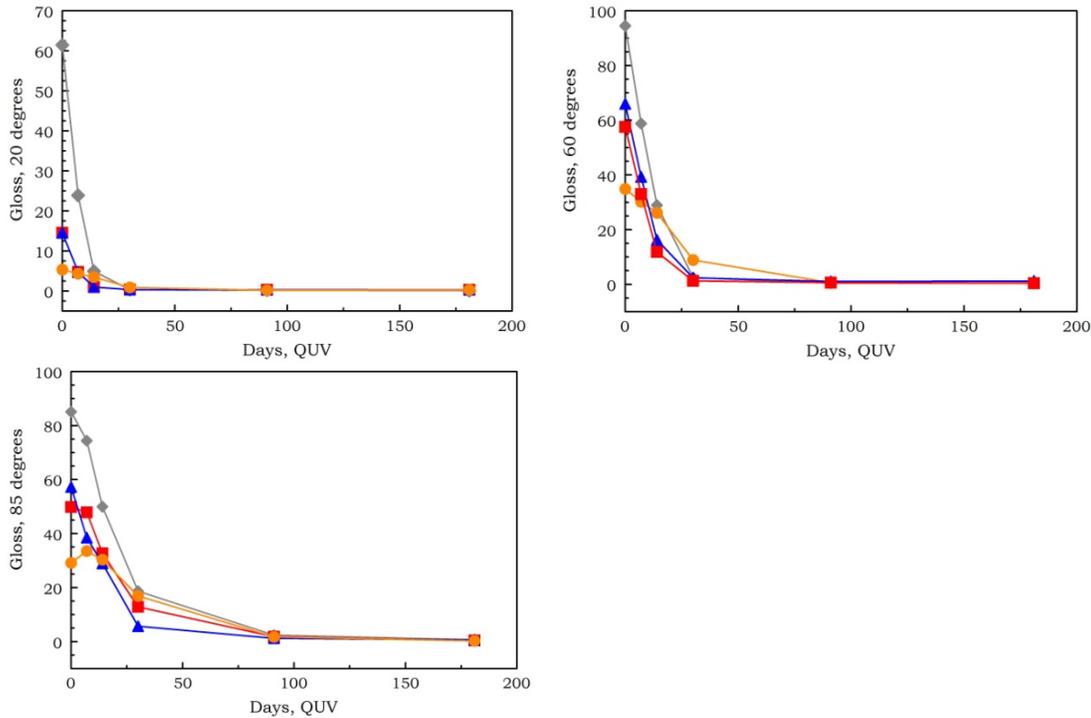
The gloss has diminished in all cases to a low value after 6 months of QUV exposure. This is very characteristic of gloss measurements after weathering and typical of such coatings since they are aromatic polyurethanes. The four coatings had appreciably different surface texture which influenced the trends in the data at 60 and 85 degrees. In all cases, gloss has deteriorated to very low values and cannot show any further change after more exposure. One month was sufficient to diminish the 20 degree gloss readings to essentially zero.

Figure 2. Trends in gloss with the exposure period in QUV accelerated weathering. For each coating the data are averages taken from 3 panels with 5 readings on each panel.

Results are separated into those taken at 20 degrees, 60 degrees and 85 degrees. The 20 degree is most representative of normal observation and is not very sensitive to the surface texture imparted during the spraying of the coatings. Grazing incidence, 85 degrees, is very sensitive to unevenness in the surface and is not usually useful for studying changes due to degradation.

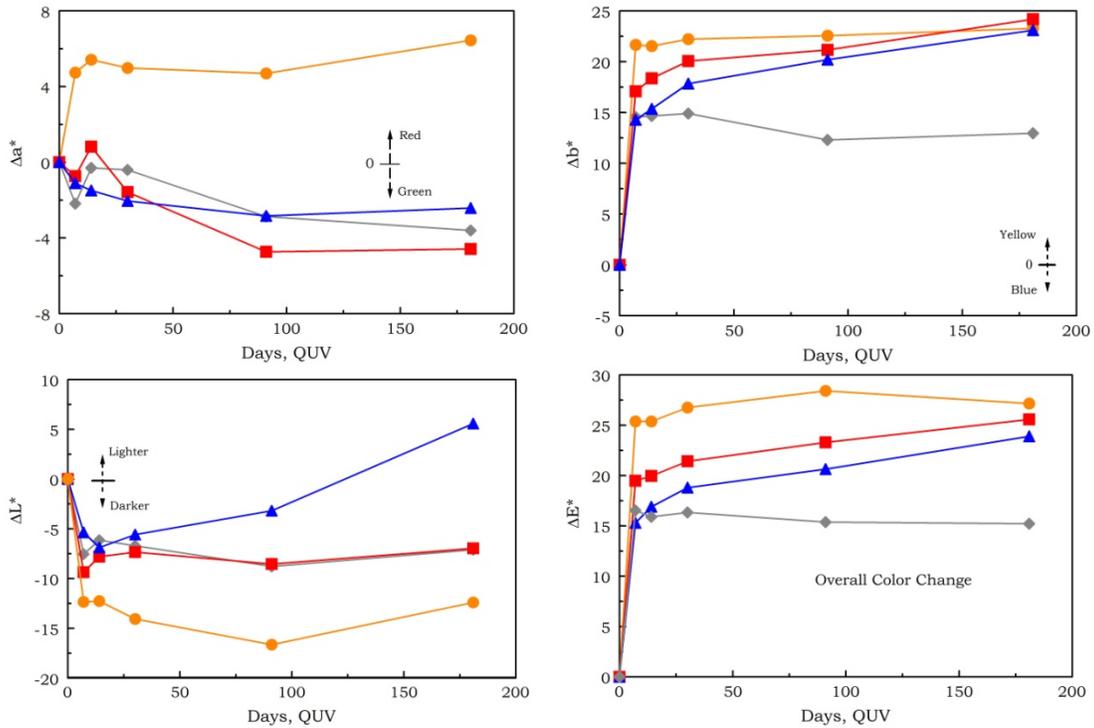
Color measurements are less sensitive to surface texture. The results in figure 3 are from 3 panels and 3 places on each panel. Again, these are typical of the rapid change to be expected in aromatic polyurethanes.

In all cases, the color changed substantially after exposure for one week, but less thereafter. These coatings all changed color faster than they lost gloss. The change in overall color, ΔE , is dominated by the yellowing and the change in lightness. Changes in color coordinates, as conventionally measured, are not independent of each other. The change in lightness will be due to the increase in yellowing, making the coating darker, and due to the reduction in gloss because the coating is not reflecting as much light and thus becoming darker. Again, the changes in appearance, color in this case, have reached a point where they do not change significantly and will not be indicative of further degradation as the coatings continue on exposure.

Figure 3. Color change after exposure in QUV accelerated weathering. CIELAB color values here are obtained using the D65 (daylight) spectrum.

ΔE is the composite change incorporating the three components of color; lightness (L^*), red-green (a^*) and yellow-blue (b^*). Decreasing L^* means that the coatings are darker. Increasing a^* shows that a color is becoming more red whereas a negative change indicates that the color is shifting towards green. Yellowing is shown by the results for Δb^* where the increase in value is consistent with the behavior of aromatic polyurethanes (reduction in b^* would mean that the color is becoming more blue).

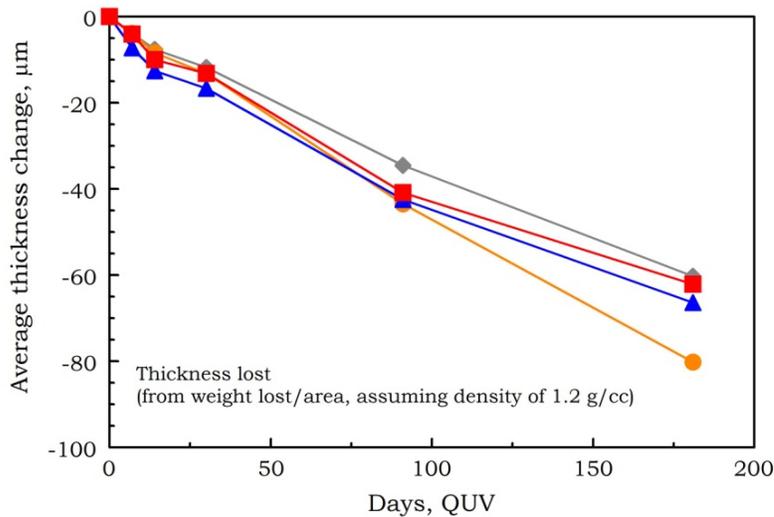
Weight loss continues with exposure although the changes in gloss and color seem largely complete. All of the coatings continue to degrade and be eroded. If a typical coating was sprayed with a dry film thickness of 30 mil (762 μm), the samples here have lost approximately only 8% (~ 60 μm) of their thickness after 6 months (~181 days), or approximately 0.33 $\mu\text{m}/\text{day}$. Weight loss, or reduction in thickness, is a useful method of evaluating degradation and often follows a more or less linear trend throughout an exposure [Bauer 1996, Gu 2001, Wypych 1995].

Figure 4. Thickness reduction calculated from weight loss of free films in QUV exposure. Density of all the coatings was assumed to be 1.2 g/cc. 25.4 µm = 1 mil.

Pipeline coatings are very much thicker than coatings used in other decorative or protective applications, where the dried film thickness is more often 2 mil (50 µm) approximately. In that case, these thinner coating formulations would have been worn to almost nothing after 1 month in the QUV and would have failed at that stage. In contrast to the thick pipeline coatings, the time scale for the change in gloss and color, in such thinner coatings, would have more closely matched the time scale for complete failure.

For these typical pipeline coatings in the accelerated weathering here, the loss of gloss and the change in color, which are surface or near-surface properties, have ceased to correlate with the continuing reduction in thickness, because the coatings are so thick.

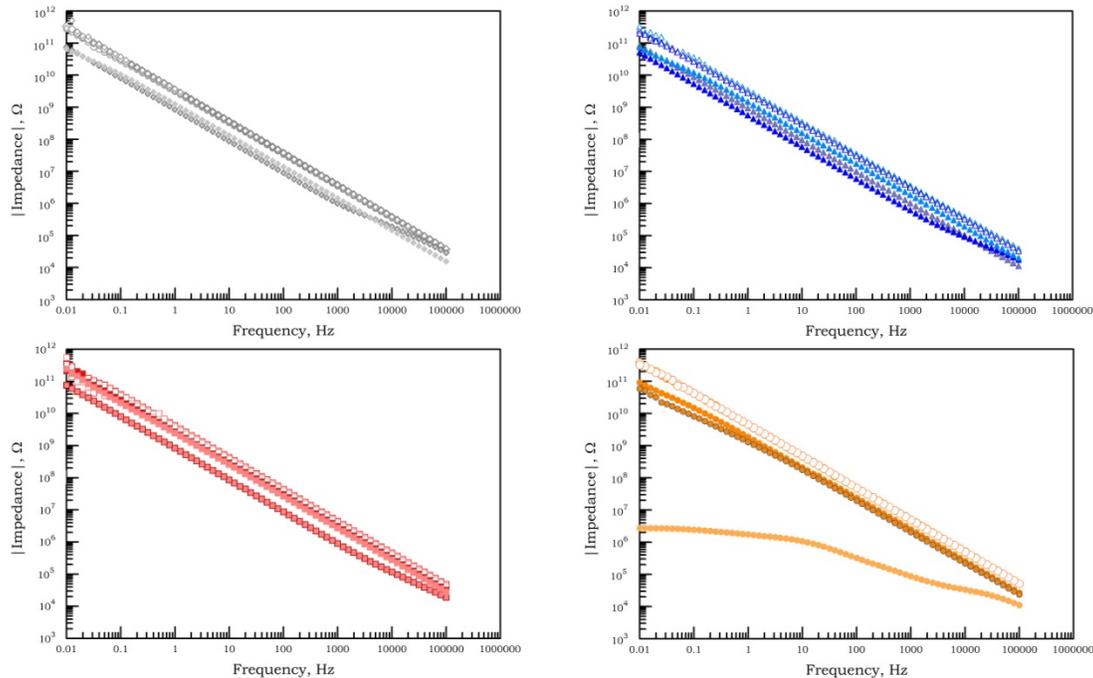
Figure 5 compares the ‘Bode’ plots of the unexposed material with the response of the coatings after 6 months accelerated exposure. For each of the 4 coatings, there are 3 replicate panels being tested. Almost all of them have very high impedance which is the result of being thick, protective films.

Open symbols denote the data from the initial, unexposed coatings; the solid symbols show the data after 6 months exposure in the accelerated testing where some slight changes are apparent. The data taken at intermediate exposure intervals is not shown because it is indistinguishable from the initial data on these graphs.

Figure 5. EIS results, all three samples of each coating. Symbols and colors show impedance data from the same coating formulation. Impedance of the unexposed samples is shown by the open symbols (higher values on each graph); impedance values after 6 months are shown using filled symbols.

None of the samples show any visible signs of corrosion. However, one of the orange (circle) samples shows a substantial loss of impedance across the frequency spectrum. All the other samples continue to have very high impedance, especially when one considers that a low frequency (0.01 Hz) impedance of greater than 10^9 ohm is considered to indicate a protective barrier coating.

Impedance is determined by dielectric material properties and is also proportional to the thickness of the material remaining. If the material properties of the coatings in this study are not changing due to chemical change, the impedance will be reduced by 8% due to their loss in thickness. A change of only 8% would be very difficult to perceive on the logarithmic axes in figures 5.

As figures 5 and 6 indicate, only one orange (circle) sample exhibits obvious signs of very reduced impedance. This sample also showed a reduced impedance after 3 months exposure. The change in this sample is probably the result of a defect in the coating arising from contamination or other imperfection in the application process. The fact that 2 other examples of the same formulation are doing well would indicate that there is no systematic problem yet apparent with the formulation.

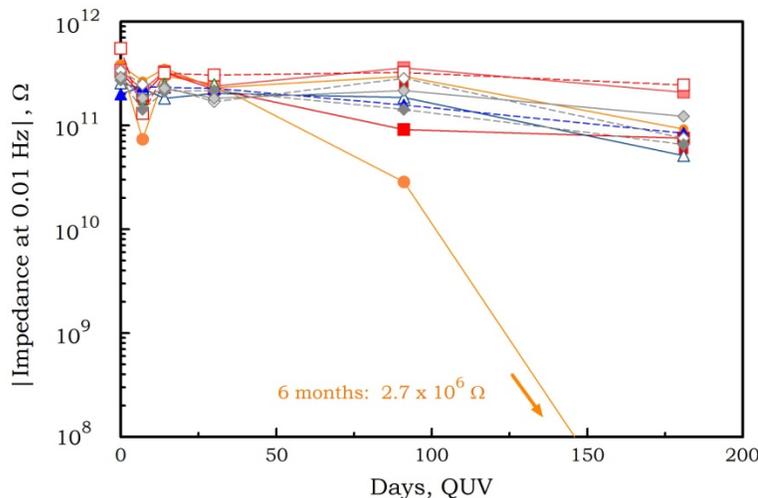
corrosion products, thus defining a service life [Su 2015, Bierwagen 2003]. Figure 6 shows the trend in impedance at 0.01 Hz of all the 3 replicates of all 4 coating formulations.

Figure 6. Coating impedance at 0.01 Hz, i.e. “coating resistance”, of all the replicates of the 4 coatings formulations. The color of the symbol and connecting line indicates the coating the coating formulation.

The low frequency impedance of most of the samples has declined only slightly. Some reduction is inevitable after this period of accelerated weathering, but the impedance values at this low frequency remain high and indicative of good barrier coatings.
