# Structural Rehabilitation of the Kenilworth PCCP Transmission Main with Steel Slipliner

## ABSTRACT

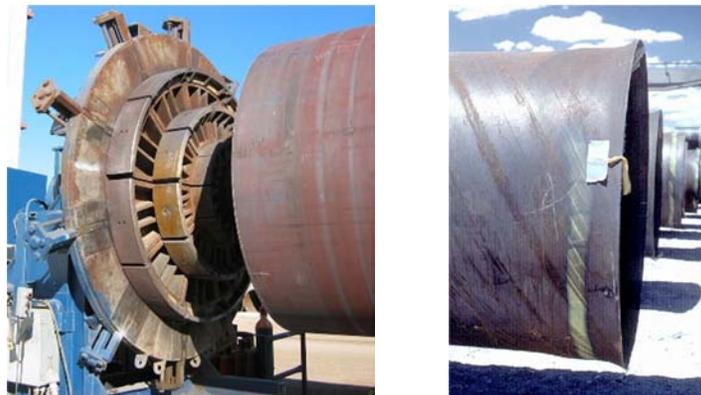
**Figure 3a, b: Hydraulic Bell Expander, Completed Bell**

Lap weld joints are provided by precision expanding one end of a section of pipe, Figure 3a, to form the bell end, Figure 3b. The spigot end is simply the cut end of the pipe.
