San Diego County Water Authority Aqueduct Protection Program since 1992: Evolution in Design and Construction of Steel Cylinder Relining of PCCP

ABSTRACT

This paper begins with a detailed look at the history and performance of PCCP in SDCWA’s transmission system, which then leads into a historic review of the Aqueduct Protection Program, how and why it came into being, covering all substantial initiatives that have been undertaken to date. A clear understanding of the sustainable approach to extending the service life of the agency’s PCCP lines is given. As a pioneer in the use of collapsible steel cylinders to achieve a fully structural renewal of deficient PCCP lines, the Water Authority has played a key role in the evolutionary development of the design and installation of these Steel Reliners. Design methods and technological developments have iteratively improved cylinder fabrication, installation processes, and quality control protocols, all of which are discussed. A case history of the on-going Pipeline 3 Relining, Sweetwater to Lower Otay, is provided to illustrate many of the topics discussed.

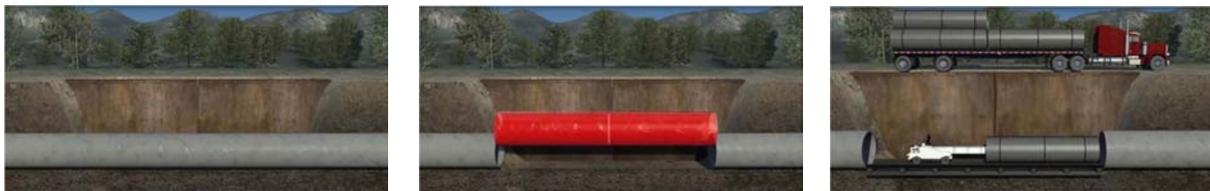
Figures 1a, b, c: Portal Excavation, Removal of 2 PCCP sections, Transport of Reliners into Pipe

Relining Process: Rahman et al. (2012) provide a brief overview of the collapsed steel cylinder relining process. PCCP relining begins with gaining access to the host PCCP line by excavating portals approximately 100-ft by 40-ft, depending on whether they're shored with steel plates or sloped excavations, Figure 1a. This is followed by the permanent removal of two 20-ft sections of PCCP, giving access to the host pipe in either direction from the portal, Figure 1b. Pipe carrier carts, usually proprietary to the installation contractor, are then used to transport the collapsed steel reliners which are bound with steel straps to hold them in a collapsed state, into the host PCCP, Figure 1c.

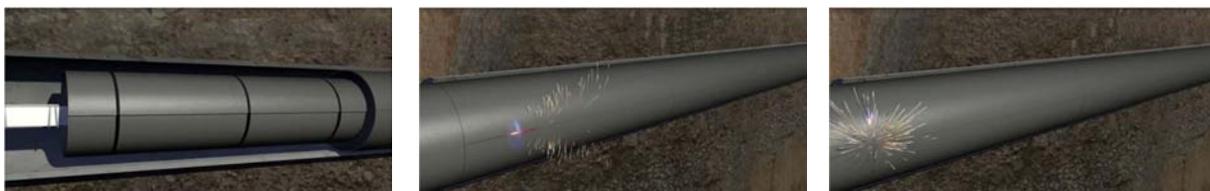
Figures 2a, b, c: Removal of Steel Bands, Full Penetration Longitudinal Seam Welding, Full Fillet Circumferential Joint Welding

As each reliner is placed at the appropriate location in the host pipe, the fit-up of that section, and adjacent sections, begins. Each section is first re-rounded by cutting of the steel straps holding it in its collapsed state, Figure 2a, followed by the use of hydraulic rams and jacks for precision fit-up. Fit-up tolerances are very tight per Water Authority specifications, to ensure the highest quality of installation. Tack welds initially hold the cylinders into place when the specified positions are achieved inside the host PCCP. Permanent welds are then applied in the form of full-penetration welds along the longitudinal seams of the cylinder, Figure 2b, and full fillet welds circumferentially to join the bell-and-spigot joints of adjacent sections of reliners, Figure 2c.

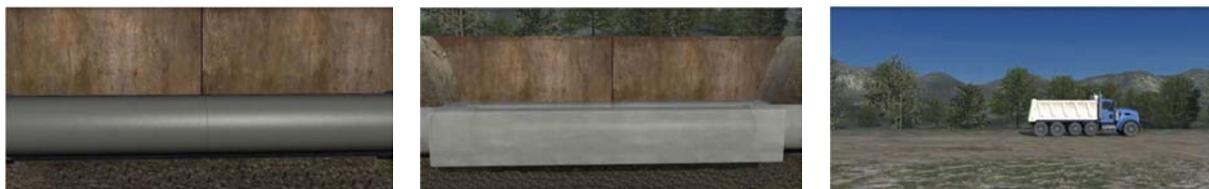
Figures 3a, b, c: New Steel Pipe Sections Placed at Portal where 2 Sections of PCCP was Removed, Reinforced Steel and Concrete around New Pipe, Portal Backfilled

are installed periodically by welding to the host PCCP Carnegie rings at joints during fit-up; these grout rings serve as grout bulkheads, partitioning off the annular space into sections, which then serve to control external grouting pressures. After the grouting operation, grout plugs secure the ports. Internal corrosion protection of the relining system is then provided by in-field application of cement mortar lining using a centripetal spray system. To complete the relining, new steel pipe sections are installed at the portal site, Figure 3a. Reinforced steel and concrete are placed around the new sections of steel pipe, Figure 3b, and the portals are finally backfilled, Figure 3c.

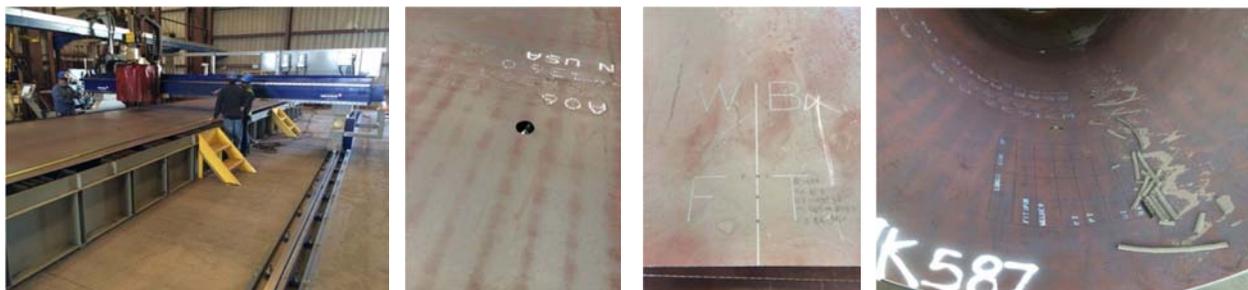
Figures 4a, b, c, d: Burn Table, Hole Cut for Grout Coupling, Orientation Etch, Grid Etched for Technical Information on Each Reliner Section

Fabrication of the collapsible relining cylinders begins with the ordering of steel plates by the pipe manufacturer. On the Sweetwater to Lower Otay (Pipeline 3) project, discussed as a case history in the next section, steel plates were ordered to “ASTM A36 Grade 36, modified to have minimum yield strength of 40,000 psi.” Steel plates were first cut to required lengths and widths on a burn table, Figure 4a. The programmable burn table squared the ends of the steel plate, cut holes for grout couplings in assigned locations on the steel plates, Figure 4b, created any required miters, and locations for spacer blocks and back-up bars were marked on the plate using an arc tracer. Other items etched on the surface included orientation of the steel plate, Figure 4c, and grids for placing pertinent technical information on each cylinder, Figure 4d.

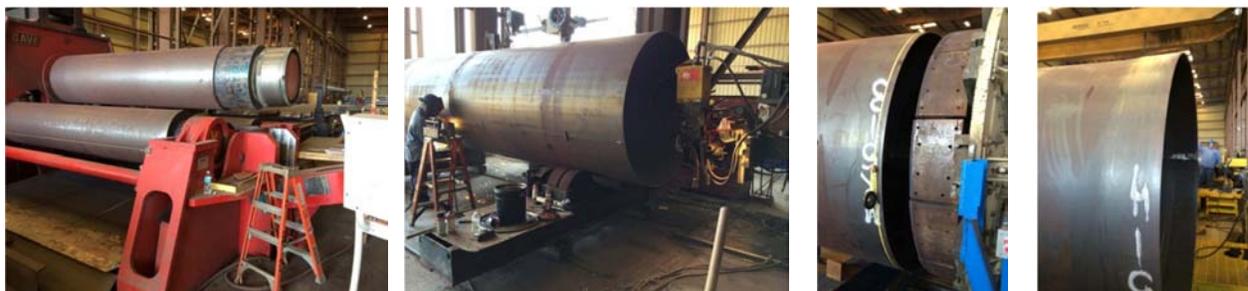
Figures 5a, b, c, d: Pyramid-type Rollers for Plate Rolling, Girth-seam Welding of two Sections of Reliner, Hydraulic Expander for Belling, Completed Bell

Plates were then rolled into cylinders of required diameters using a pyramid-type roller, Figure 5a, and tack welds placed along the longitudinal seam to hold the liner into shape. Two pieces of rolled cylinders were then fitted up for girth seam welding, resulting in the specified length of reliner, Figure 5b. Full penetration submerged arc welding was required for all girth seams; all sub-arc welds were required to be either x-rayed or undergo real time radiography. On the end of the cylinder where the weld bell was to be formed, the longitudinal seam was then welded to allow for belling to take place, Figure 5b. A bell was then formed using a hydraulic expander at the end of the cylinder where the seam weld was completed for belling, Figure 5c, and d.

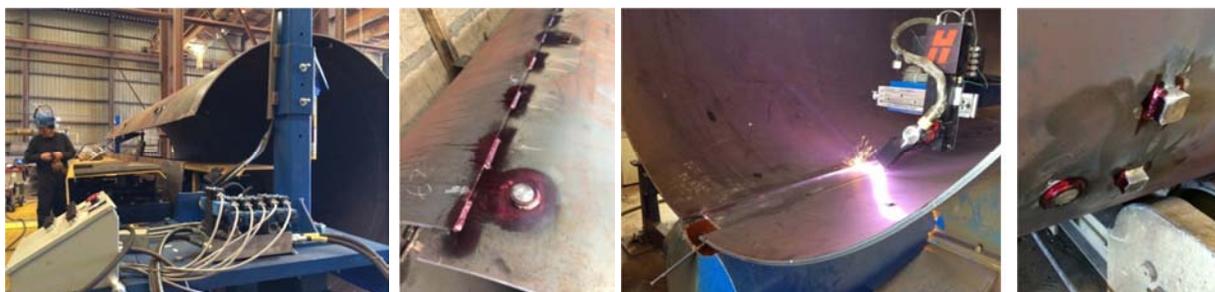
Figures 6a, b, c, d: Preparation for Backup Bar Forming, Completed Backup-Bar with Dye-Penetrant Testing Complete, Stitch Cutting of Backup Bar Prior to Collapsing, Dye-Penetrant Testing of Welded Spacer Blocks and Grout Couplings

Backup bars were made at previously etched sections of the plates, Figure 6a, and b; backup bar welds were tested using dye-penetrant. Backup bars were then stitch cut to prepare for the overlapping of the longitudinal seams for the collapsing of the reliners, Figure 6c. Spacer blocks were welded on the reliners, as were grout couplings in the previously cut holes; dye-penetrant testing was completed on each welded item, Figure 6d.

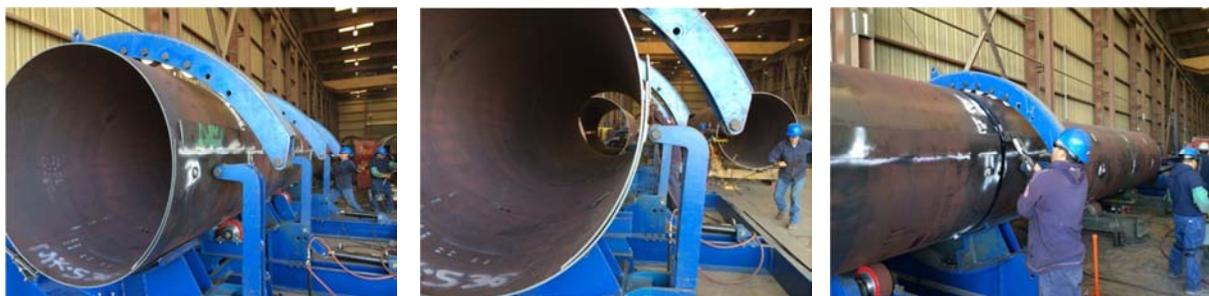
Figures 7a, b, c: New Steel Pipe Sections Placed at Portal where 2 Sections of PCCP was Removed, Reinforced Steel and Concrete around New Pipe, Portal Backfilled

The final steps included collapsing the cylinders, Figure 7a, tie bars being welded internally, Figure 7b, and steel straps placed around the outside to ensure that the liner would remain in the collapsed state, Figure 7c, until re-rounded in the field by removal of both the steel straps and the tie bars during installation. Steel liners were now ready for storage and transportation to the project site.

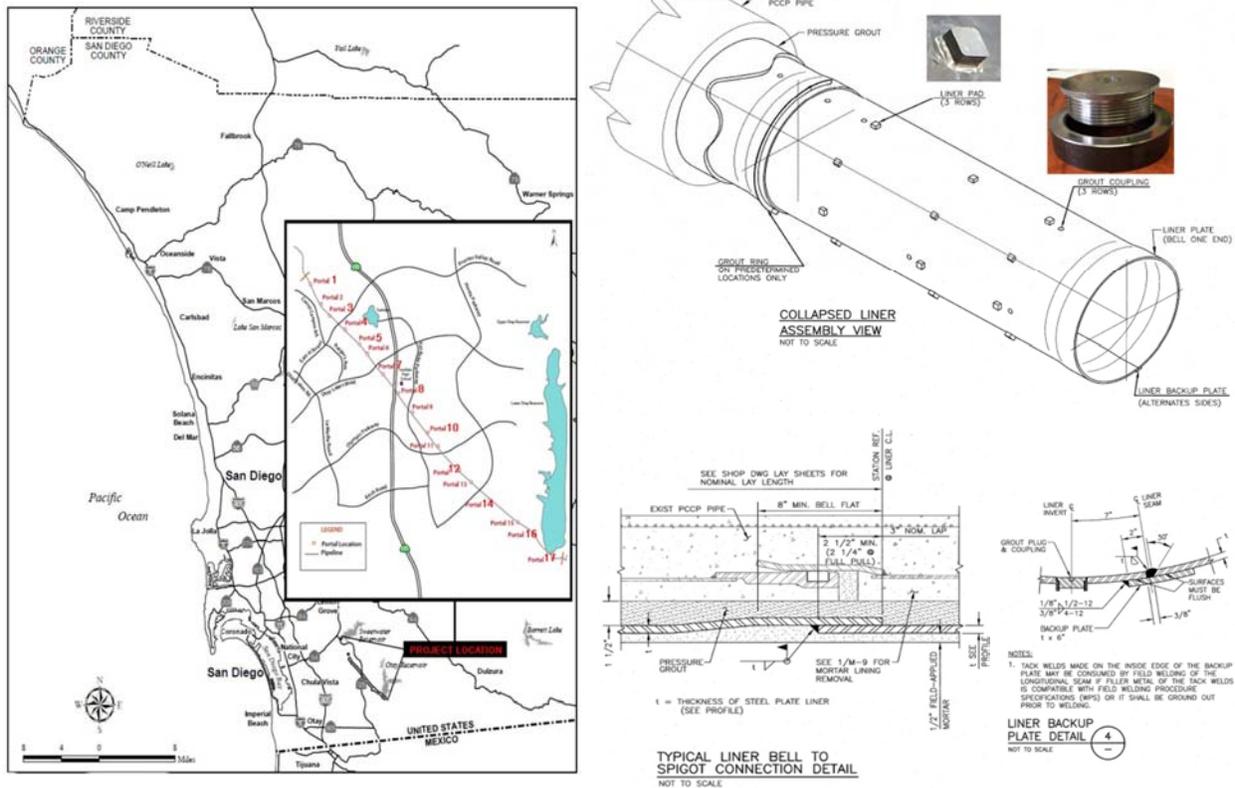
Figure 8a, b: Regional Vicinity Map & Project & Portal Locations, Pertinent Design Details

The Sweetwater to Lower Otay Pipeline Relining Project was awarded in late 2013 to LH Woods and Sons, Inc.; Northwest Pipe Company was the low bidder as the steel relining material supplier. This project involved the structural relining of approximately 5.5 miles of a 69-inch internal diameter PCCP line that traverses portions of the communities of Bonita and eastern Chula Vista (Eastlake, Otay Ranch, as well as the Otay Ranch Preserve and Lower Otay County Park). Figure 8a shows the regional location map, as well as a project vicinity map as an insert, highlighting the pipeline and location of the portals for the relining project. Steel cylinders were manufactured to an outside diameter of 66-inch, and had a wall thickness of 3/8-inch (0.375-inch). While the initial plans were made for 17 entry portals, the Contractor was able to reduce the number of actual portals to 11, without causing any installation problems on the project. The remaining portals served as access shafts, allowing for man and other equipment entry. Figures 8b shows pertinent design details for the steel reliner cylinders on this project.

of the two sections of pipe facilitated man-entry into the host pipe as well as insertion of collapsed steel reliners, Figure 9c. Full size portals were located at points 1, 3, 4, 5, 7, 8, 10, 12, 14, 16 and 17, shown in Figure 8a.

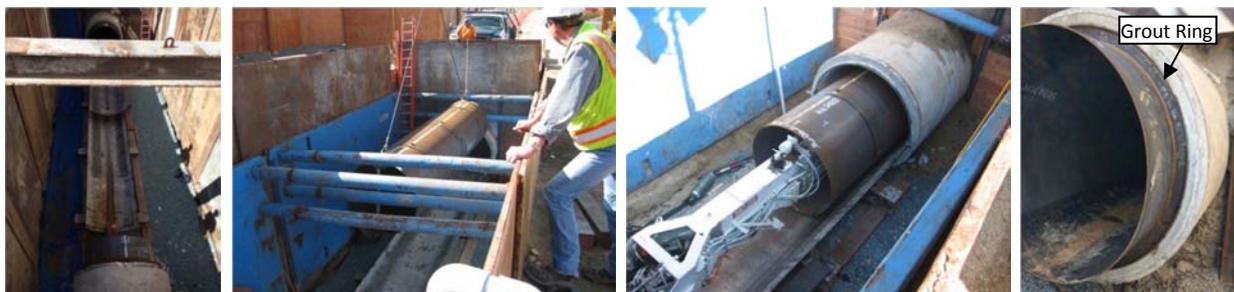
Figures 9a, b, c, d: Portal with 2 Sections of Host PCCP Removed, Steel Reliner being Lowered into Portal, Insertion of Reliner Section into Host Line on Pipe Carrier Cart, Installed Grout Ring

The process utilized for this relining project was essentially performed as described previously in this paper. 11 full size portals were made to enable the removal of 40-ft, or two sections of the host PCCP, Figure 9a. Once reliners were lowered into the portal, Figure 9b, removal

Welders were able to fit up and weld up to 700-ft of reliners/day. For the 20-ft sections of reliners, about a dozen tack welds were placed longitudinally and circumferentially as part of the fit-up process. Based on grout density and the use of 14-ft lift heights, the number of grout rings (means by which grouting pressure is controlled to prevent buckling of steel cylinders), which was originally numbered at 290 for the entire project, was cut in half. This directly affected installation productivity rates since subsequent liner installations beyond a ring must wait until grout rings have been fit up, welded and tested using dye penetrant. Figure 9d shows a grout ring in place.
